REVISED TREE ASSESSMENT REPORT

Re-assessment of *Araucaria columnaris* (Cook Island Pine)

Located at: 62-64 Beachcrest Rd WELLINGTON POINT QLD 4160

7 May 2013

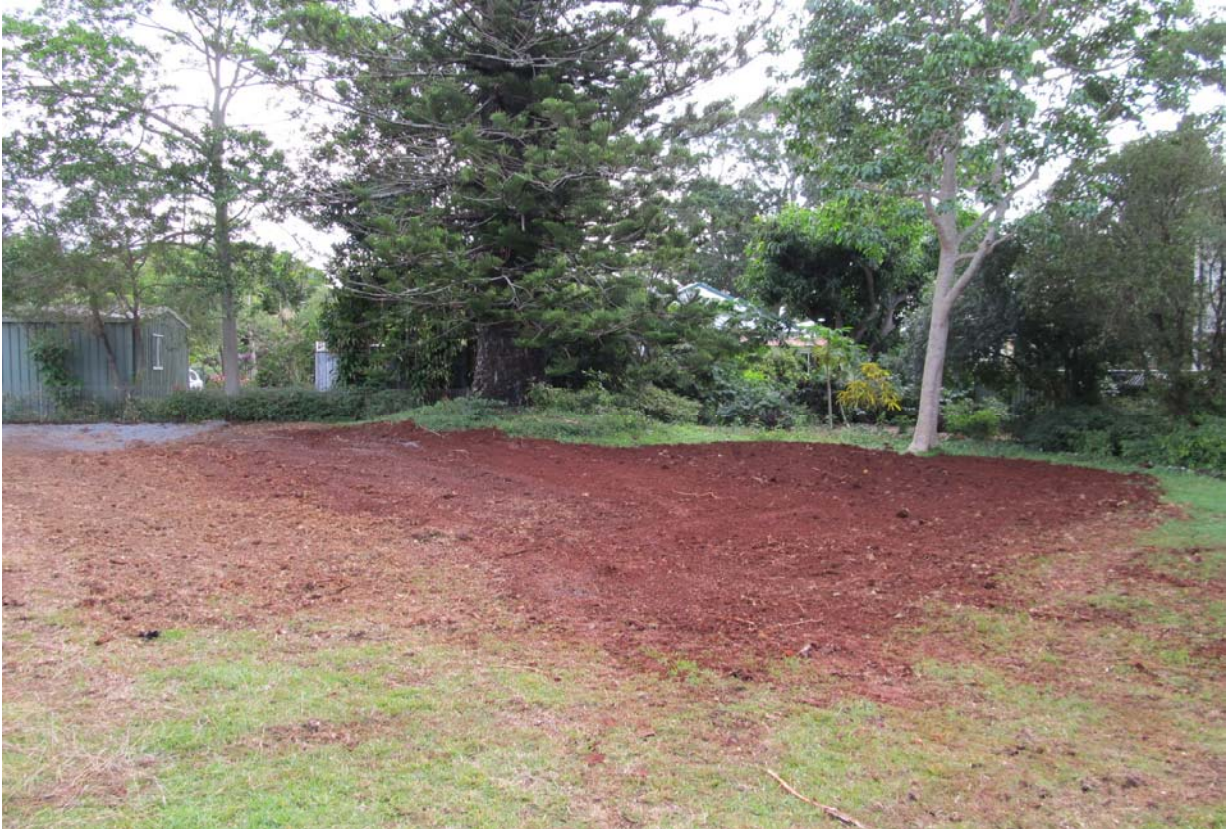
As the trench has been dug within the root zone and close to the structural root zone, and filled in, it is difficult to assess the impact and extent of damage done to the primary and secondary roots of this tree.

Without accurate information, it is impossible to determine the extent of root damage and whether it was caused by the trenching, or by the removal of the brick edging. At this stage it can only be assumed that damage to both primary and secondary roots has occurred, rendering the tree potentially unstable and at risk of failure, or at least with declining health. Even with minor root damage, these trees can become unstable due to their intolerance to root interference.

Photograph 1 showing clay over spoil from trench spread around base of tree

- **Further investigation is carried out to determine extent of root damage; and**
- **The property owner, engage an independent Arborist to undertake an assessment of the tree and root zone.**

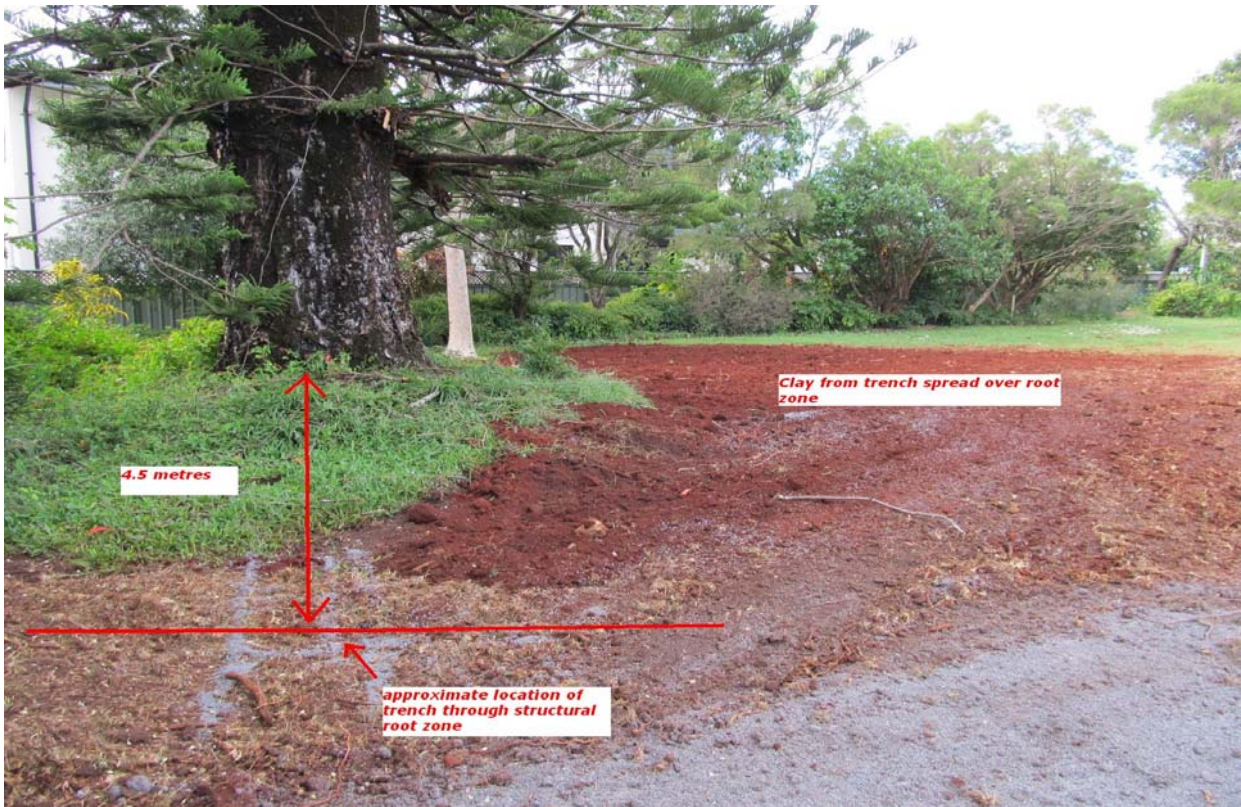
This was investigated on 3 May 2013. A site meeting was had with the new property owner and the status of the tree was discussed. When asked where the red dirt spread around the base of the tree had come from, the property owner advised that Council had come in and dug a 'huge' trench on his property alongside the tree for the purpose of a sewer connection or alignment. When asked how deep the trench was, the property owner said he could stand in it and his head was about level with the ground. The red clay over spoil was littered with ripped pieces of root, indicating damage had been done to the root zone. When asked where the trench was located, it was shown by the property owner to be approximately 4.5 metres from the trunk of the tree and equally as long. The property owner did not know who spread the stockpiled spoil but believed it was the previous owner next door.

Photograph 2 (location of trench as suggested by property owner)
