19.6 RABY BAY REVETMENT WALL TRIAL AND REPORT

Raby Bay Repair Trial assessment report

Redland City Council (RCC) has commissioned a project to trial various stabilisation treatment methods to address the history of ongoing revetment wall movement observed within the Raby Bay Canal Estate (located in Cleveland, QLD).

The purpose of this document is to summarise the Repair Trial process and detail the methodology and results of the Repair Trial assessment.

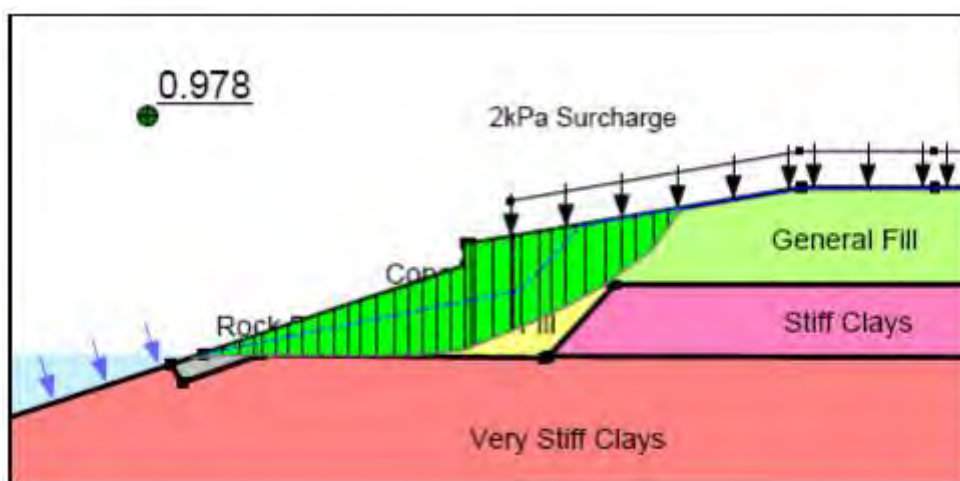
- A shallow slip failure was occurring in a wedge of uncompacted fill located under the rock armour, which has a maximum thickness of 3m (see Figure 1 below).
- Specifically, that the failure mode appears to be a failure in a wedge of uncompacted fill rather than a deeper circular slip extending into natural materials.
- Previous repair methods using long piles are therefore an overdesign, as such piles would be applied where a critical slip was present at depth, rather than for a shallow slide.

Figure 1: Shallow failure mechanism proposed by KBR [2]

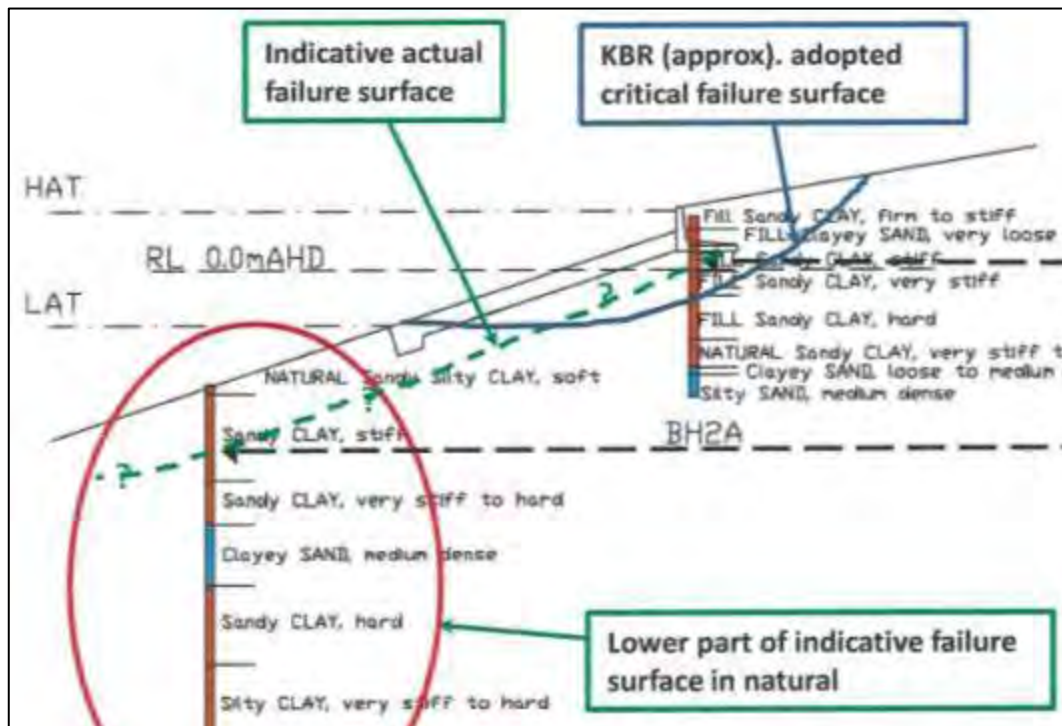
- Conversely to KBR's conclusion, GHD believe that, at the site at Piermont Place assessed, a translational slide is occurring in the fill and extending down the canal batter into the in situ material (see Figure 2 below), as the natural material is likely low strength due to fissuring and/or softening.
- The ground conditions at Raby Bay are variable and that, where failure planes and trigger mechanisms are not well understood or defined, it is reasonable to use more conservative and robust solutions that, to some degree, account for some uncertainty and the potential for lower strength natural materials.
- As failures occurring in the natural material are a significant risk, implementation of a "broad coverage fit and forget solution" is not recommended.

Figure 2: Shallow translational slide proposed by GHD [3]

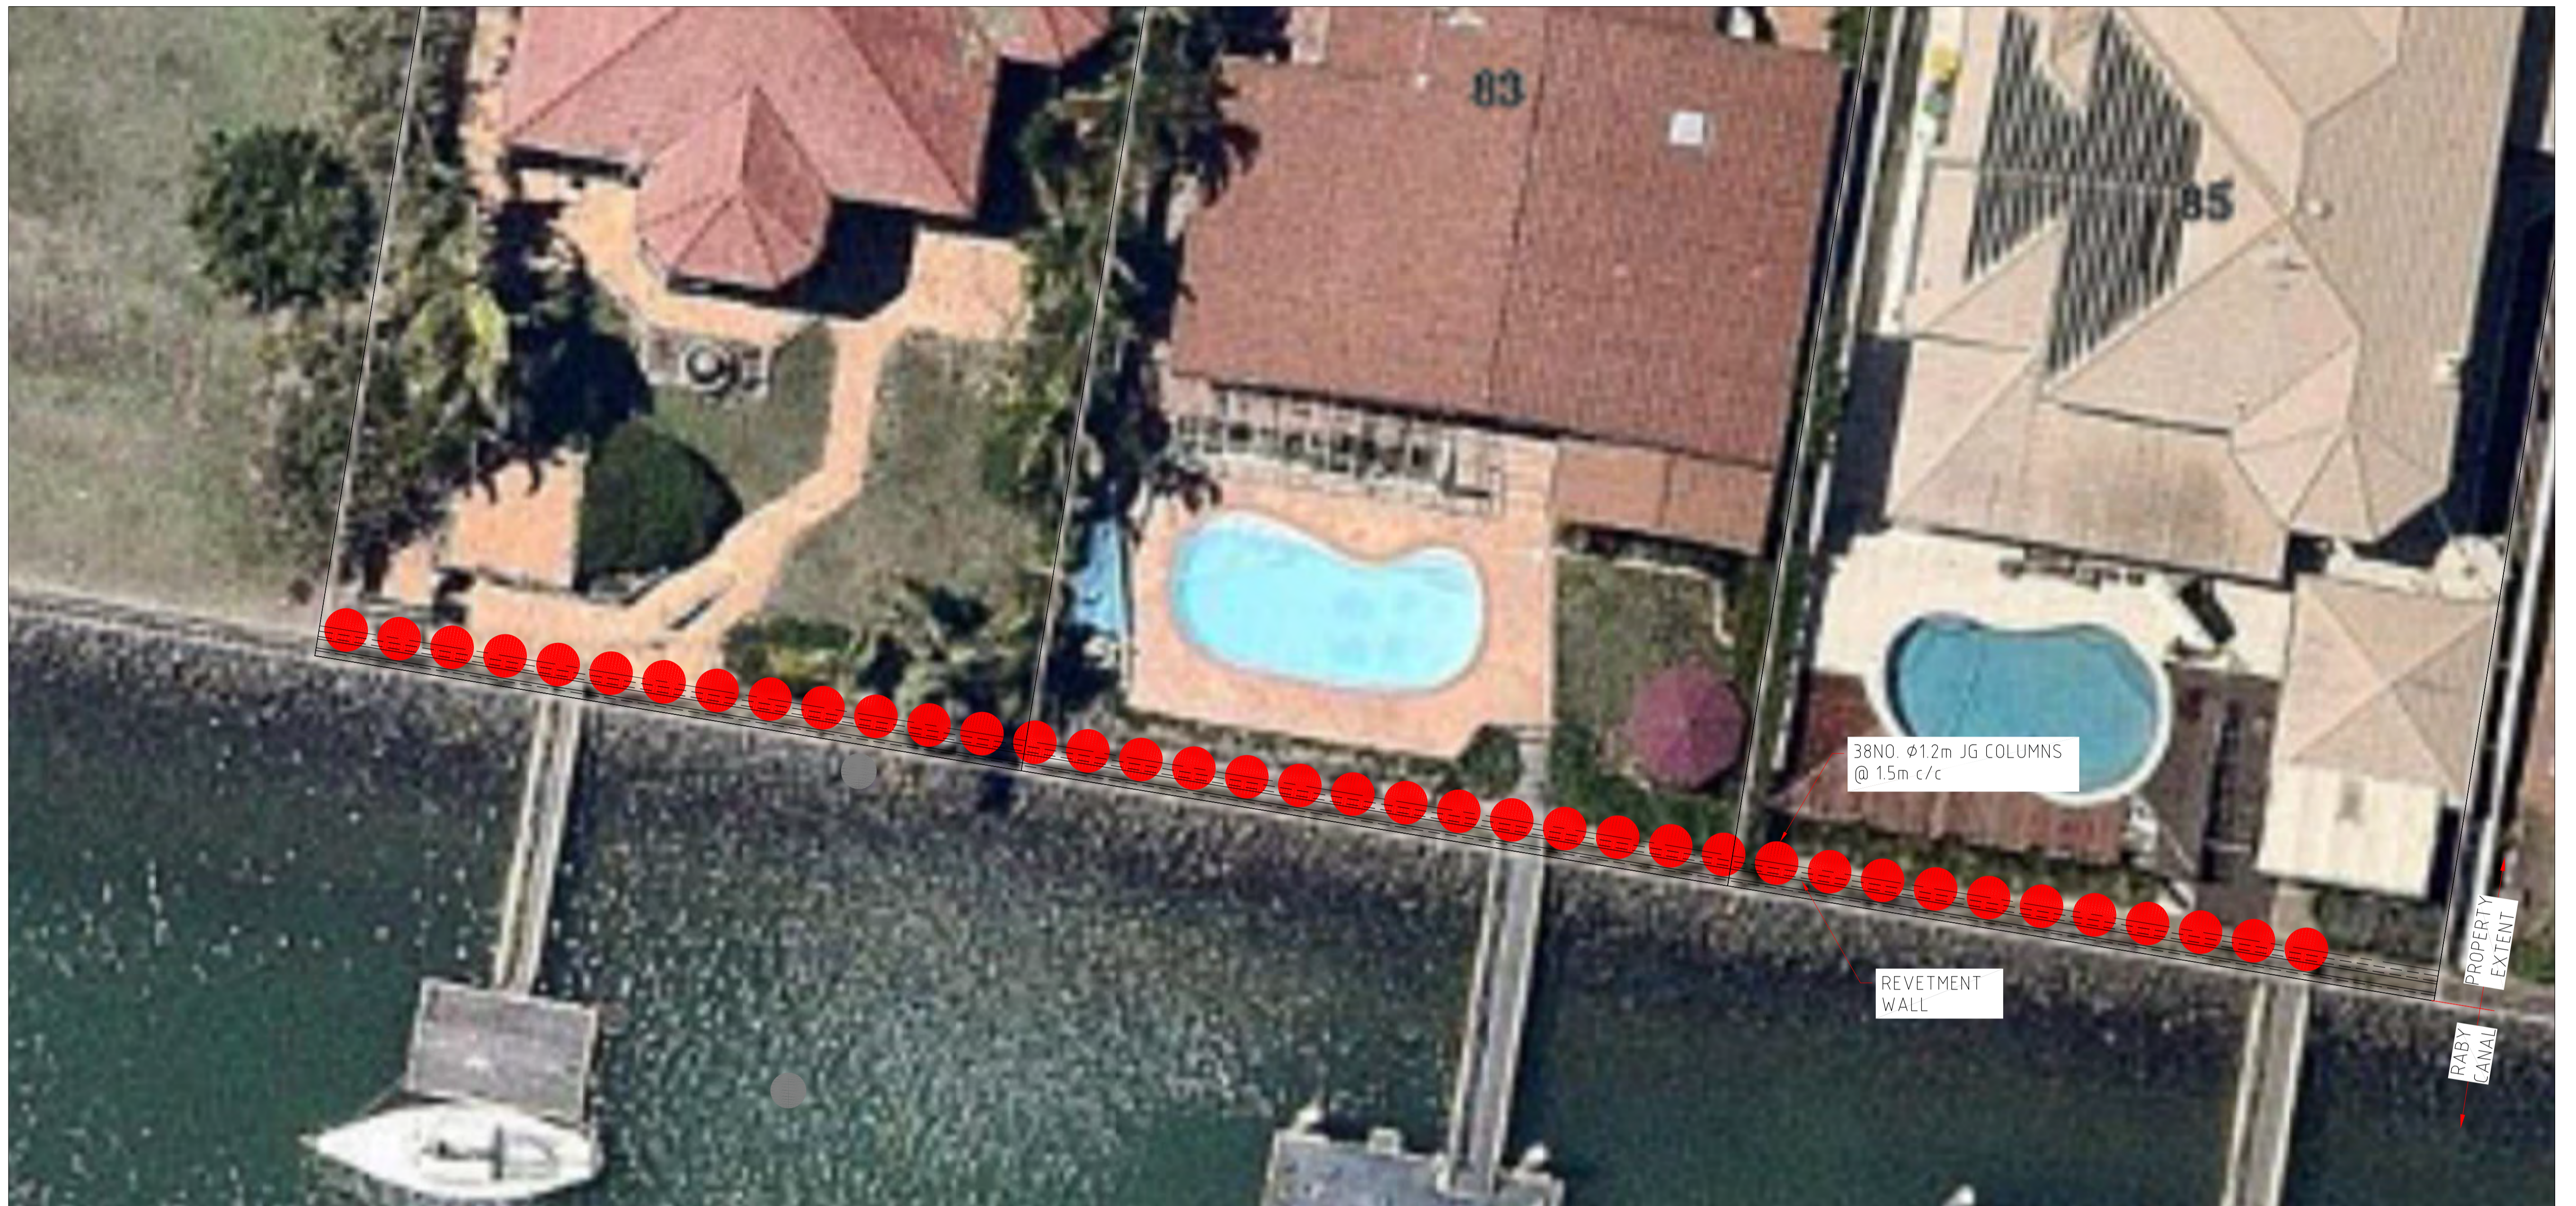
TITLE JET GROUTING STABILISATION WORKS CONSTRUCTION SEQUENCE		
SCALE 1:50 (A1)	DRAWING No 5040198-DD-05	REV 1

38 OUT OF X40 COLUMNS WERE INSTALLED. LAST 2 COLUMNS ON THE EASTERN SIDE OF 85 MASTHEAD DRIVE WERE NOT INSTALLED DUE TO EXCESSIVE MOVEMENT OF THE REVETMENT WALL.

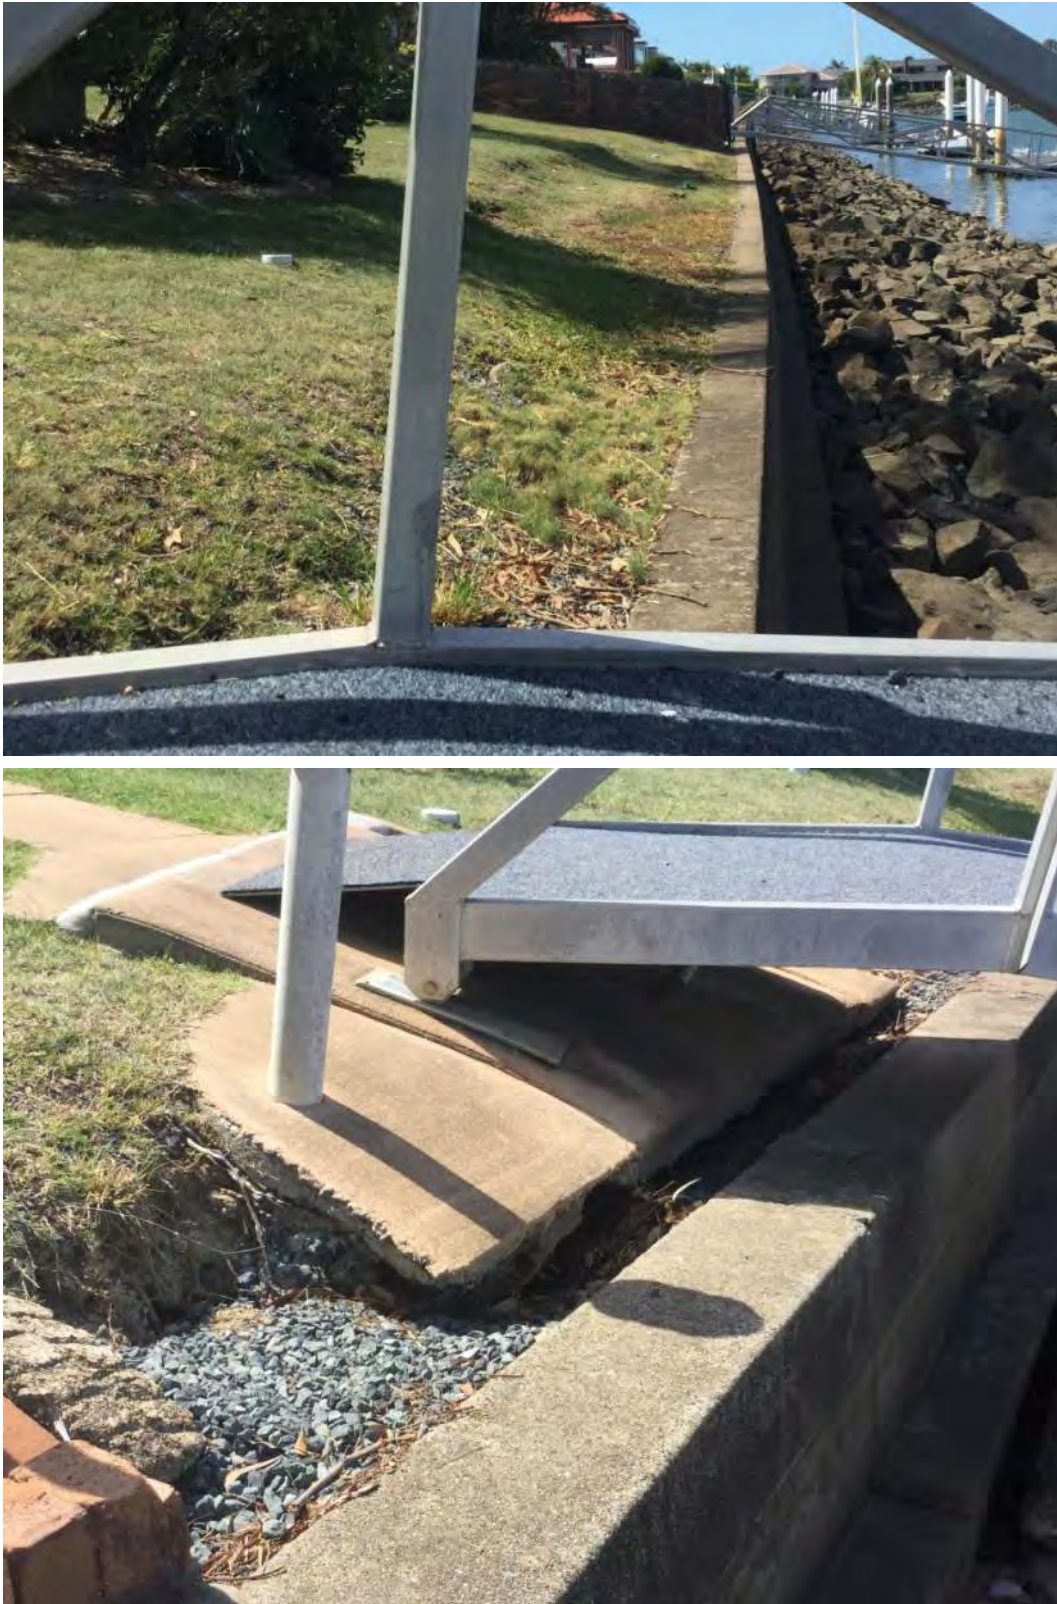
Figure 21: 7-9 Sternlight Court - Pre-construction general view looking north and view of pontoon walkway foundation slab, dated 25 January 2017

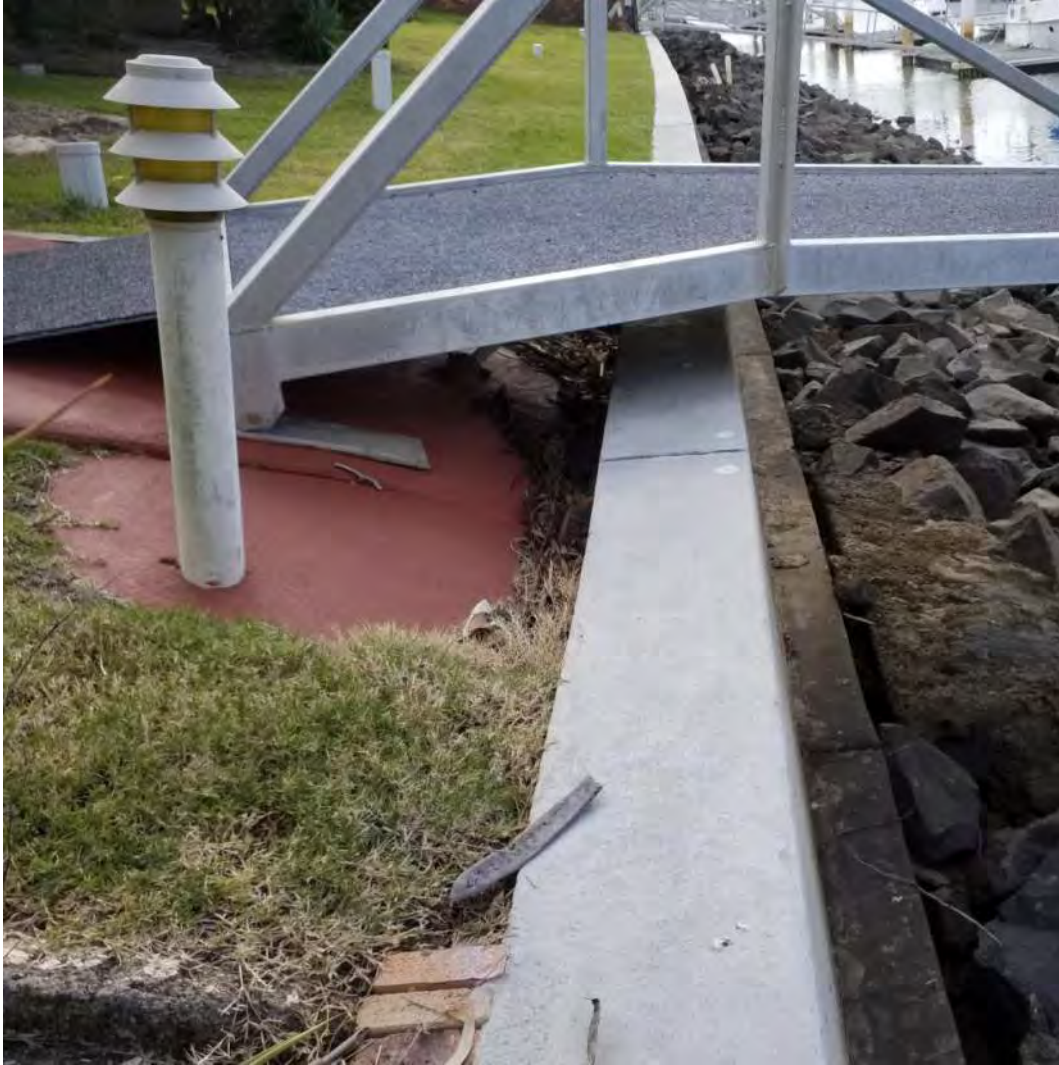
Figure 22: 7-9 Sternlight Court - Post-construction general view looking north from pontoon walkway, dated 20 June 2018 (from [12])

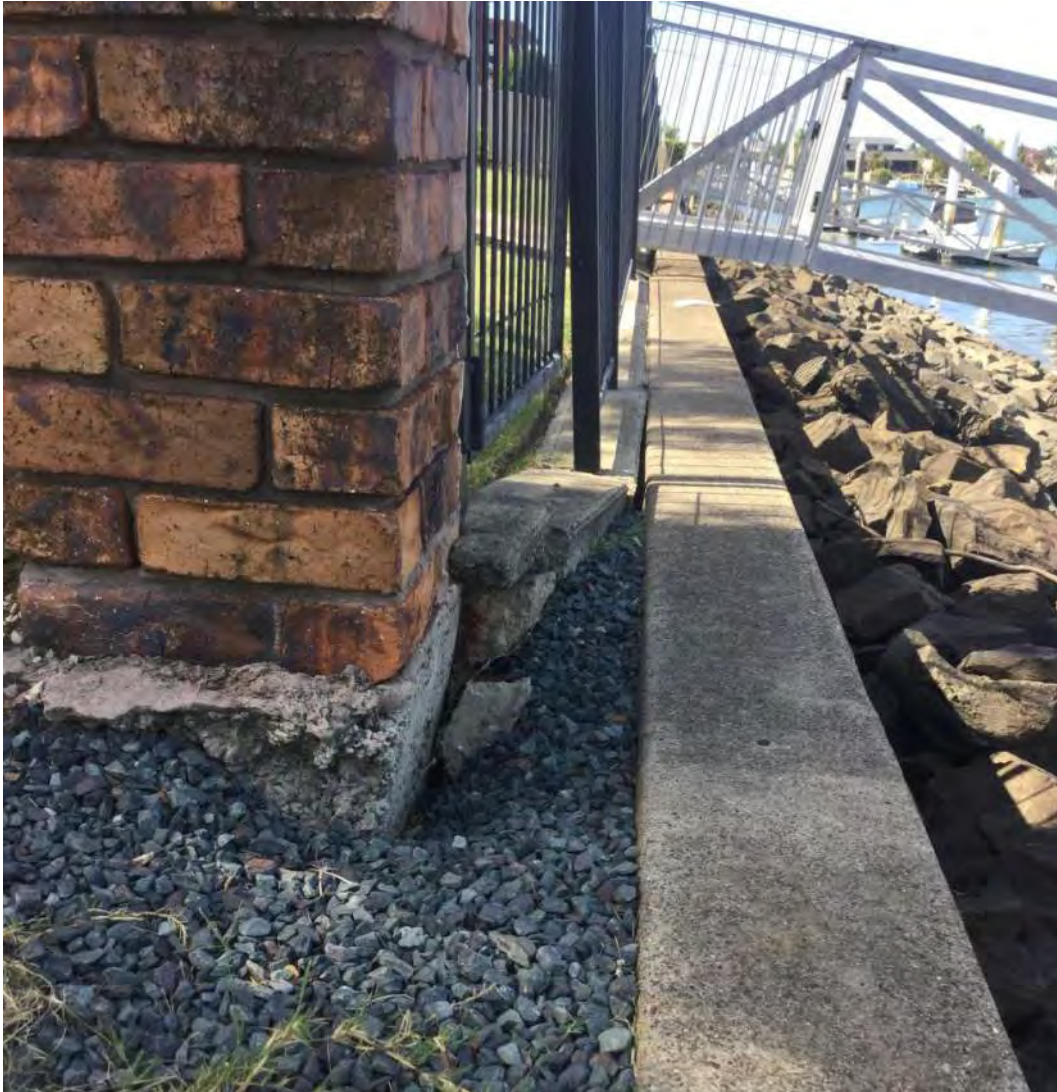
Figure 23: Sternlight Court boundary between 7-9 and 11 - Pre-construction view looking north, dated 25 January 2017

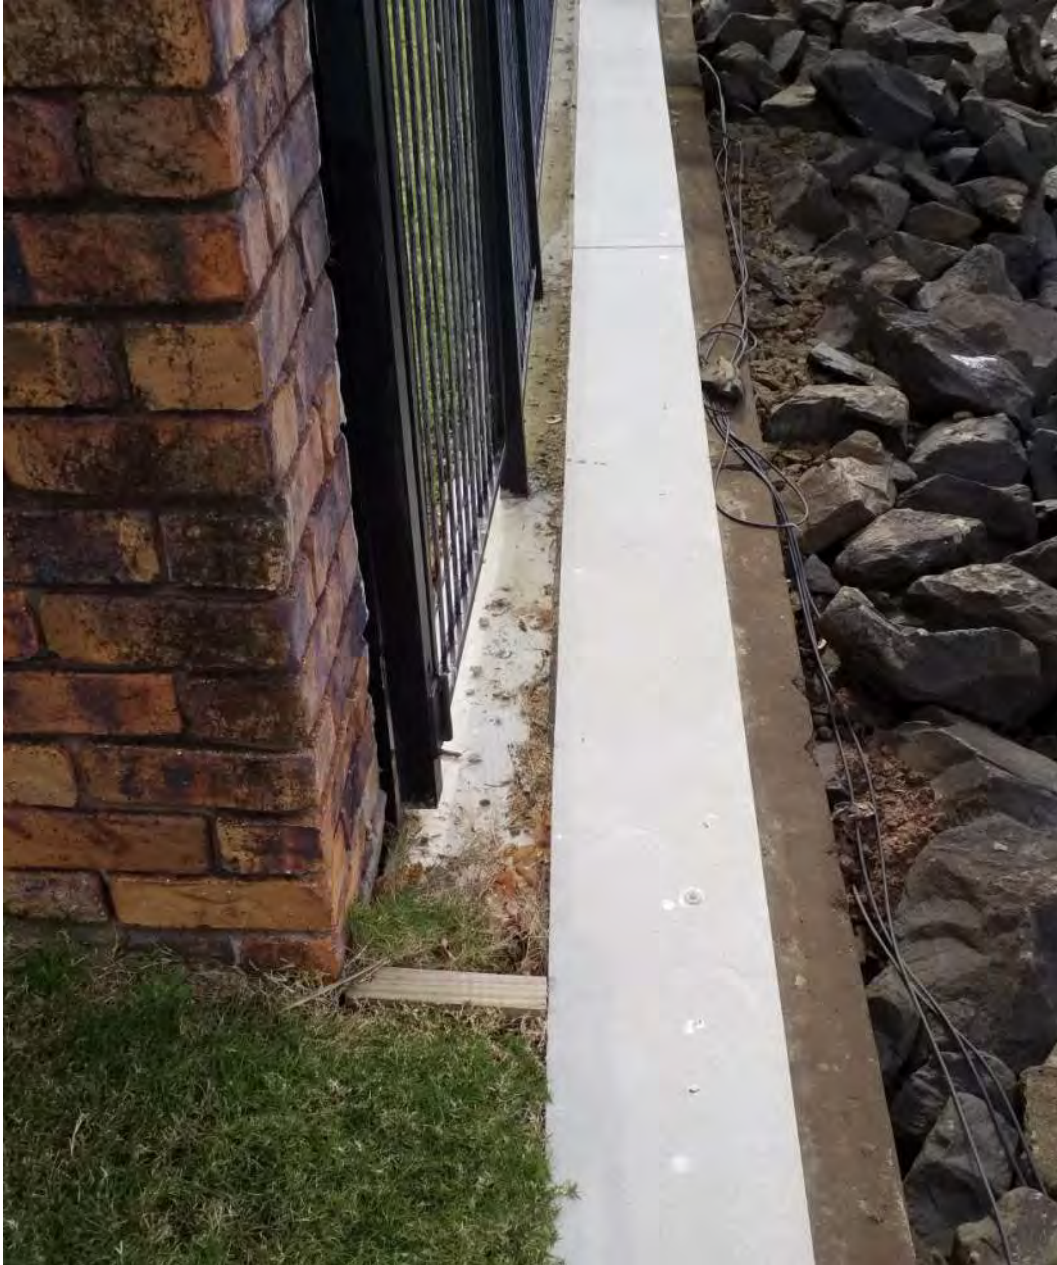
Figure 24: Sternlight Court boundary between 7-9 and 11 - Post-construction view looking north, dated 20 June 2018 (from [12])

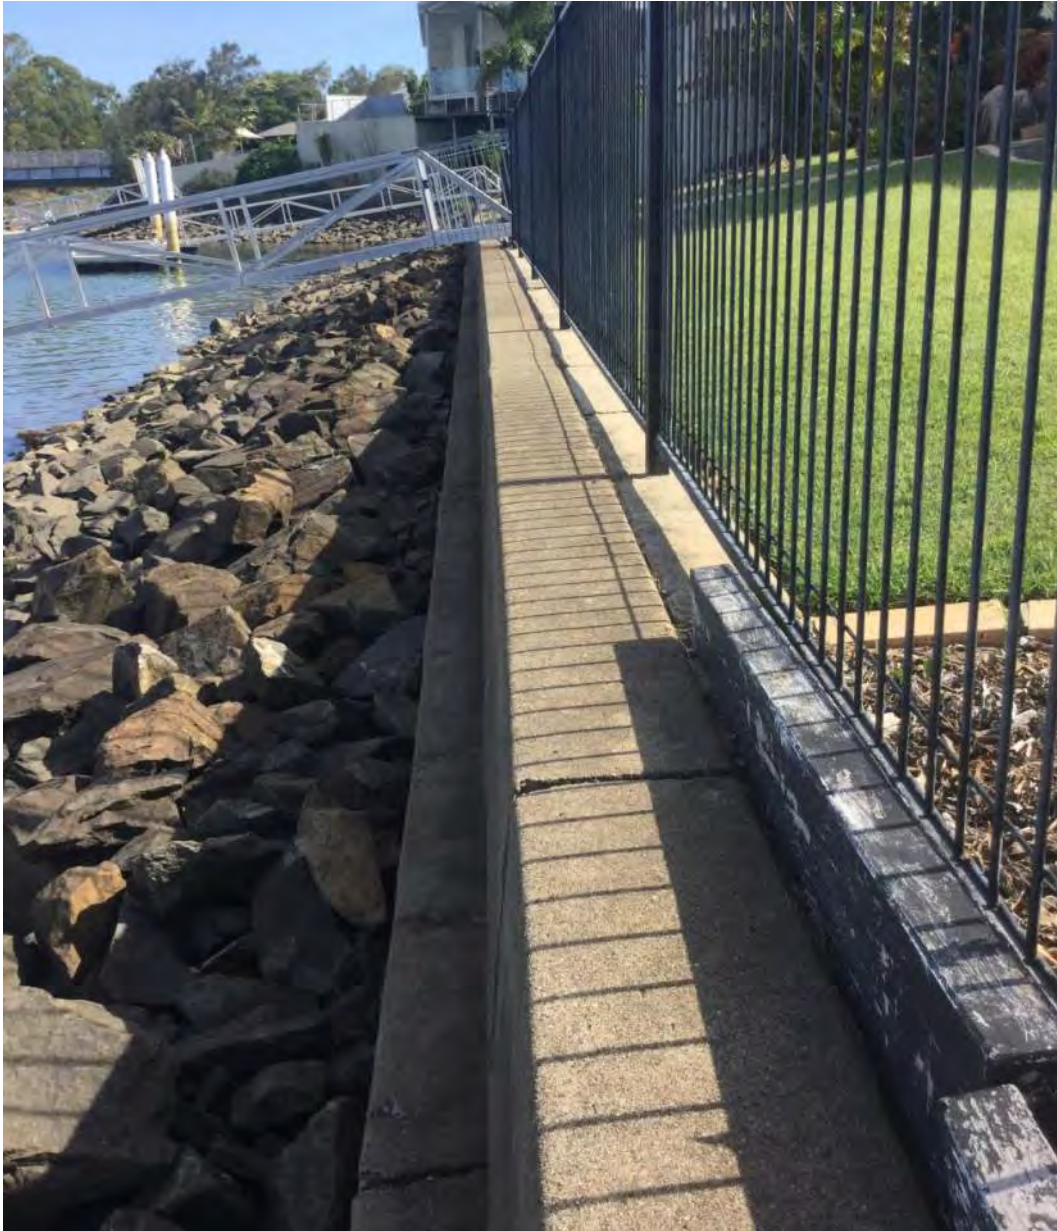
Figure 25: 11 Sternlight Court - Pre-construction general view looking south, dated 25 January 2017

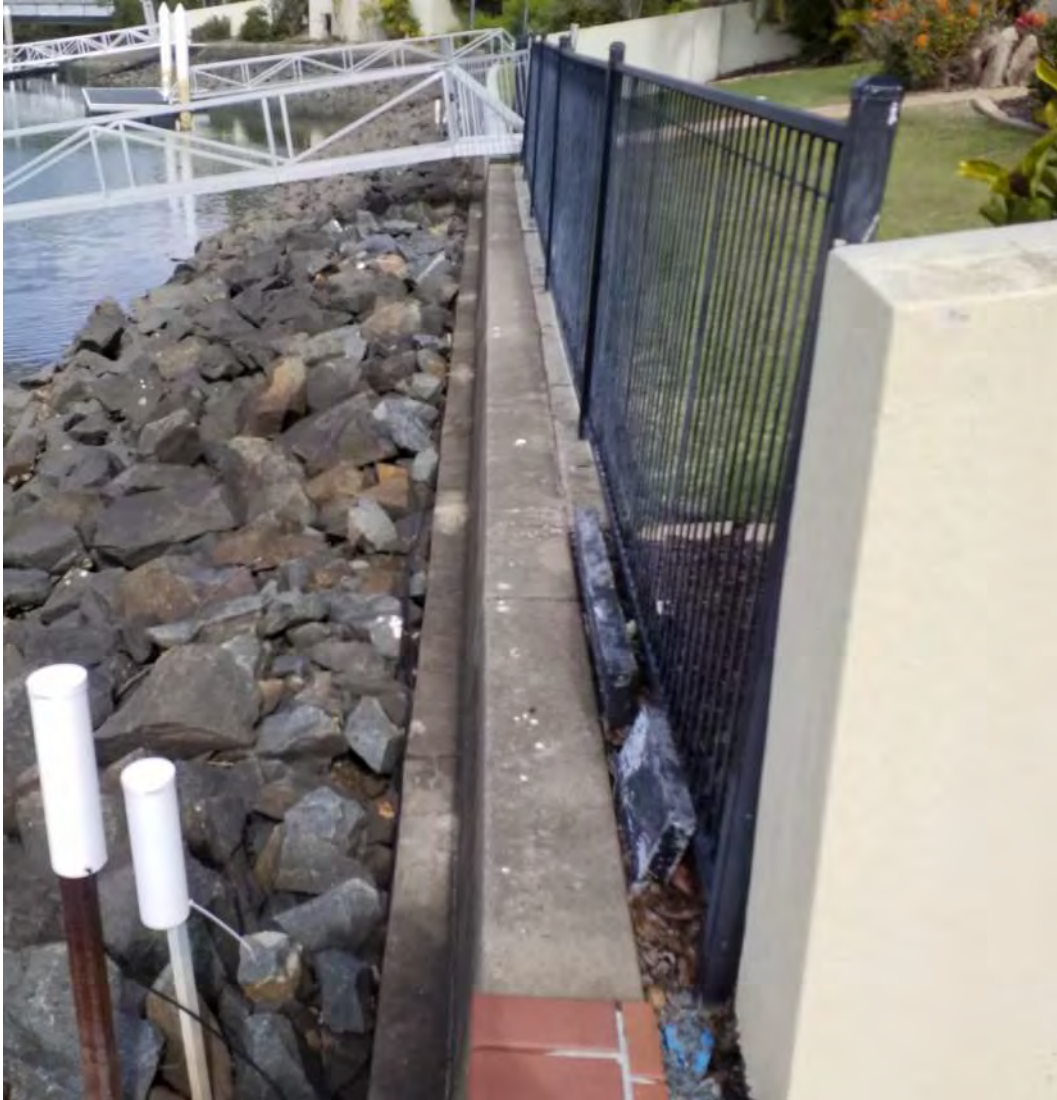
Figure 26: 11 Sternlight Court - Post-construction general view looking south, dated 20 June 2018 (from [12])

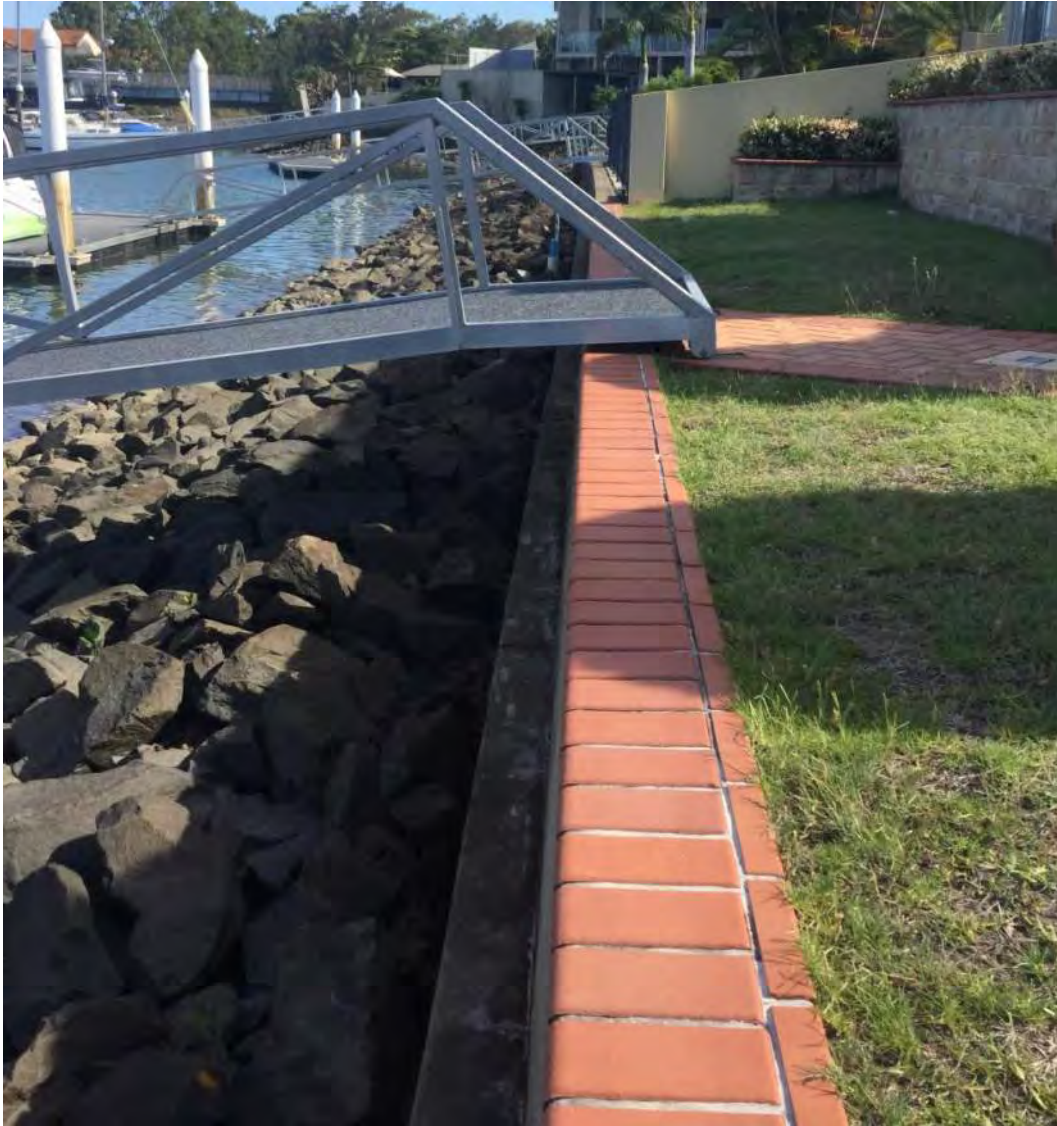
Figure 27: 13 Sternlight Court - Pre-construction general view looking south, dated 25 January 2017

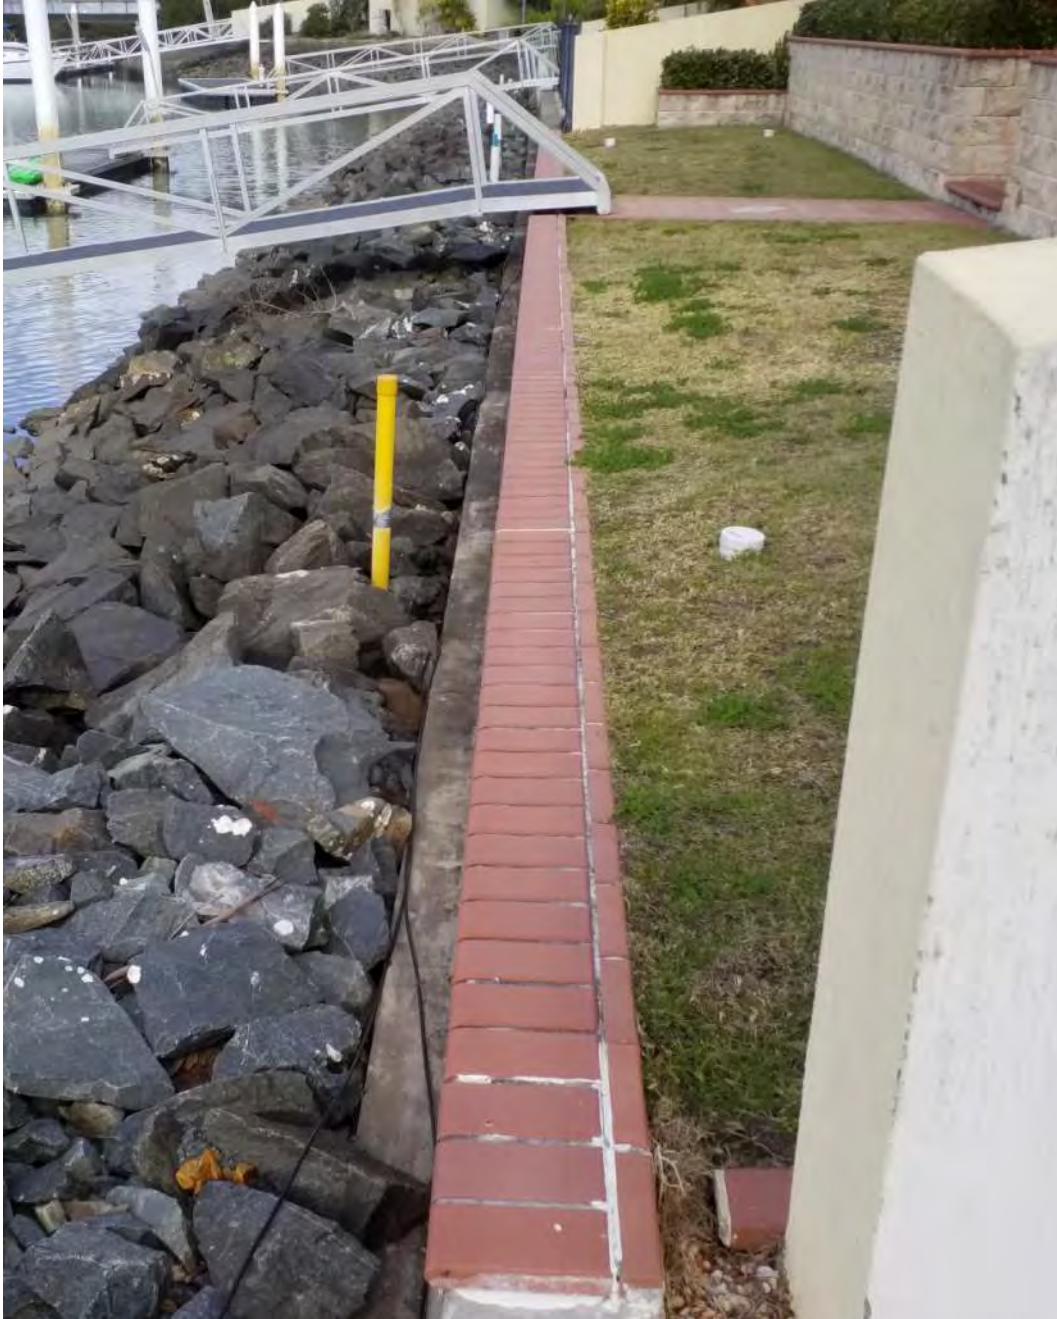
Figure 28: 13 Sternlight Court - Post-construction general view looking south, dated 20 June 2018 (from [12])

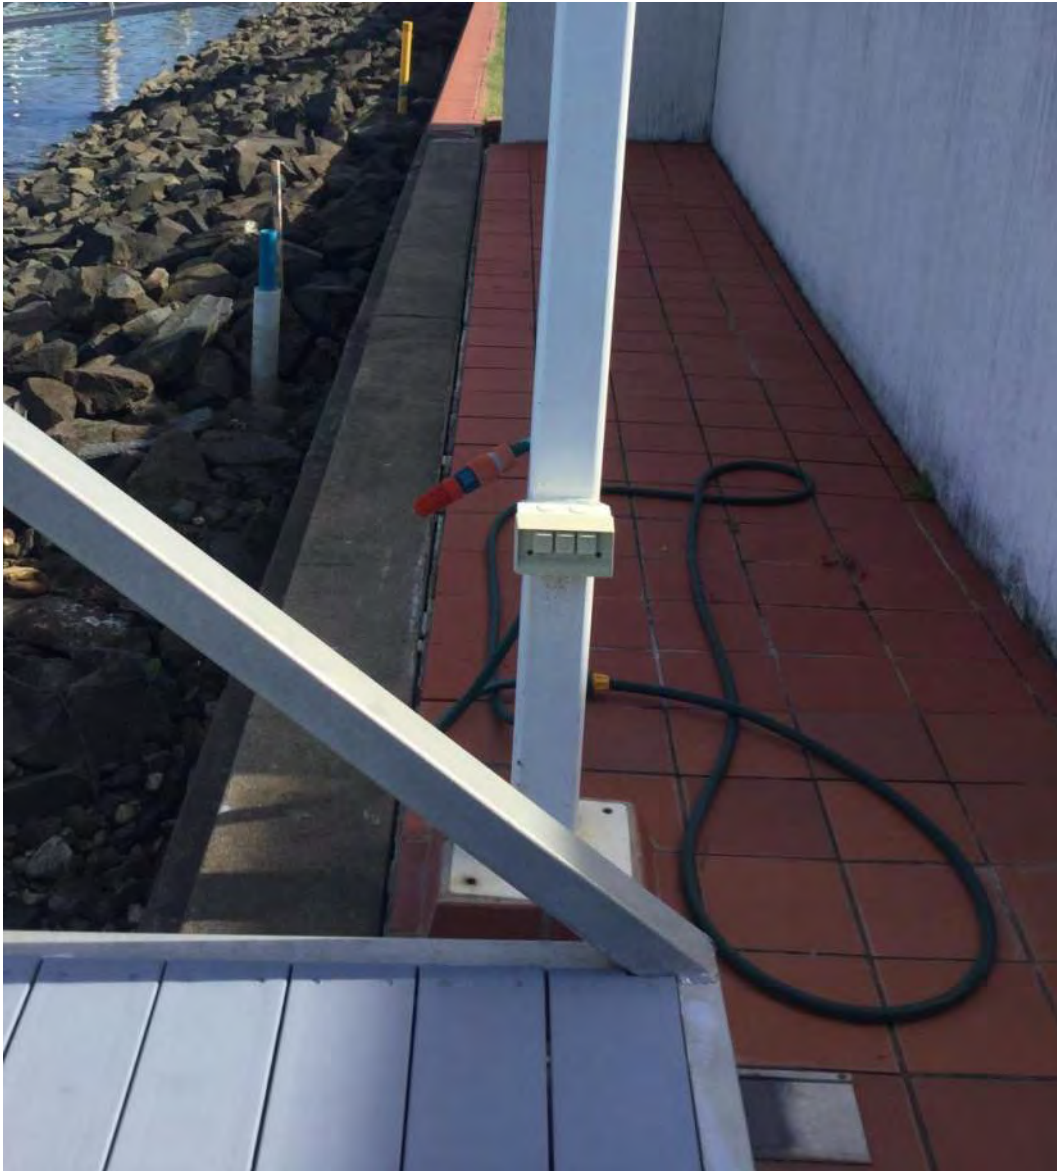
Figure 29: 15 Sternlight Court - Pre-construction general view from pontoon walkway looking south, dated 25 January 2017

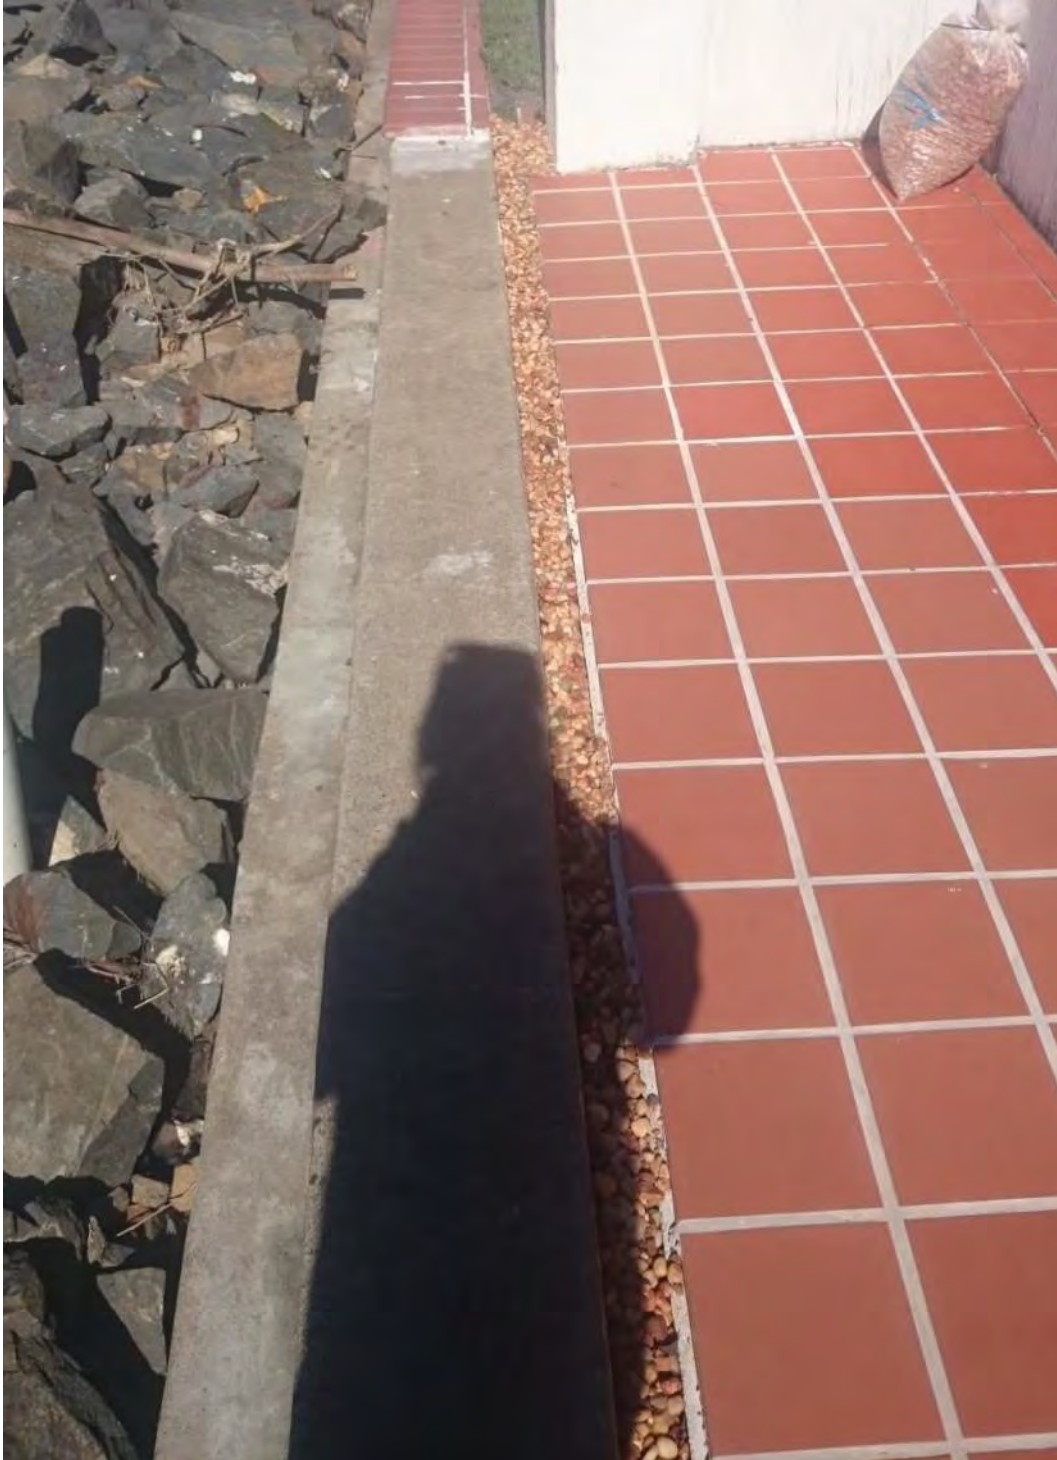
Figure 30: 15 Sternlight Court - Post-construction general view from pontoon walkway looking south, dated 5 June 2017

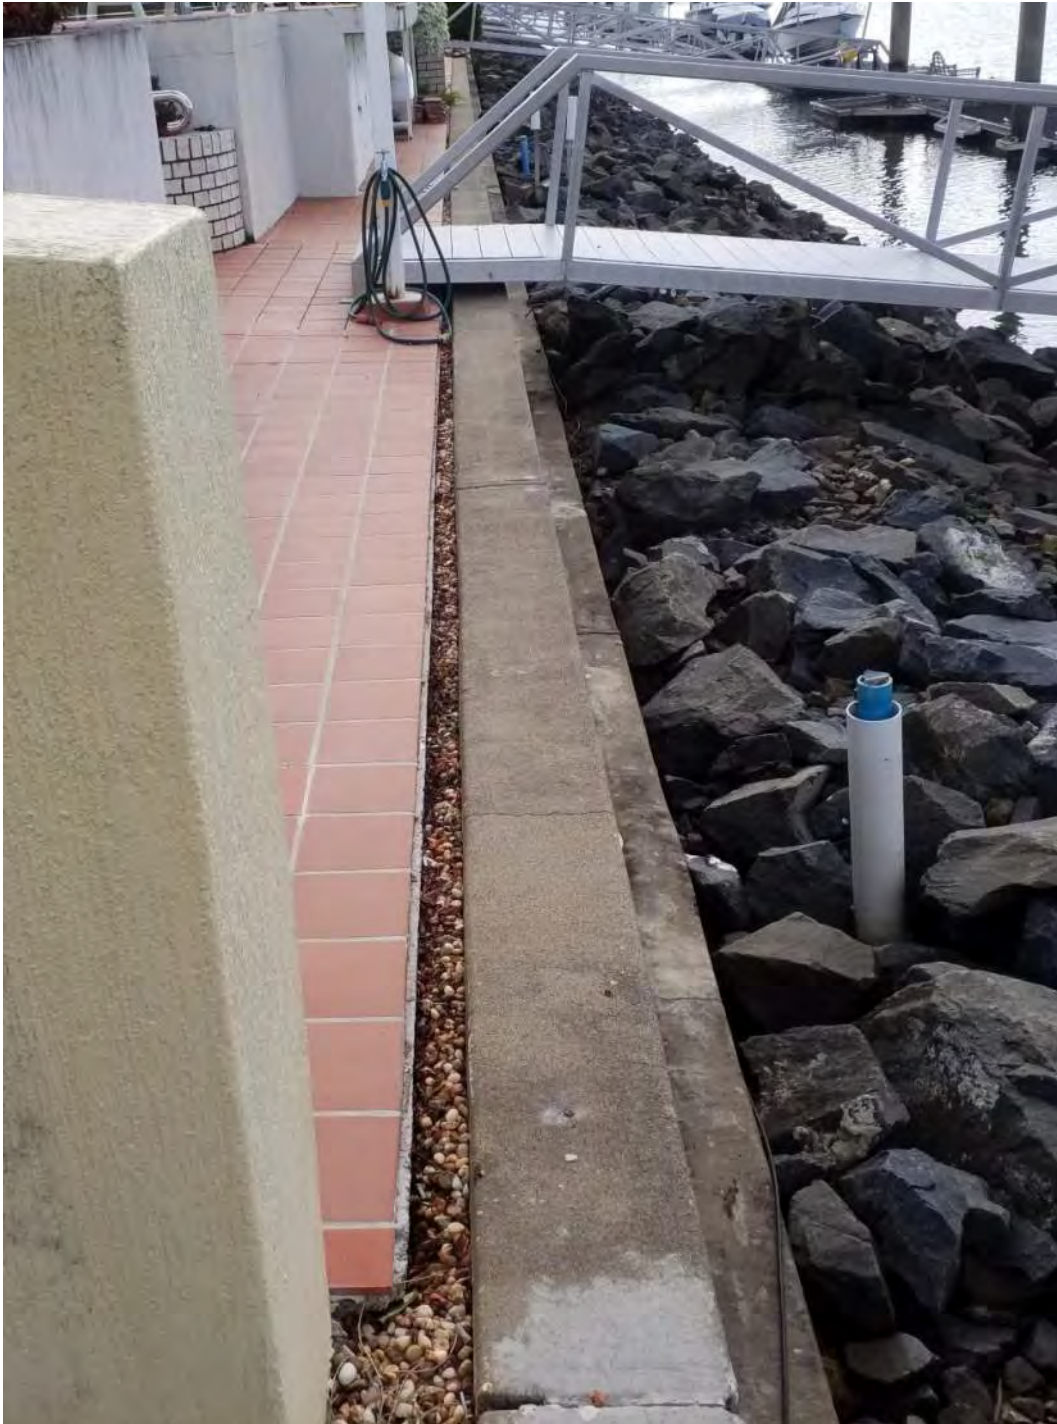
Figure 31: 15 Sternlight Court - Post-construction general view from southern boundary looking north, dated 20 June 2018 (from [12])

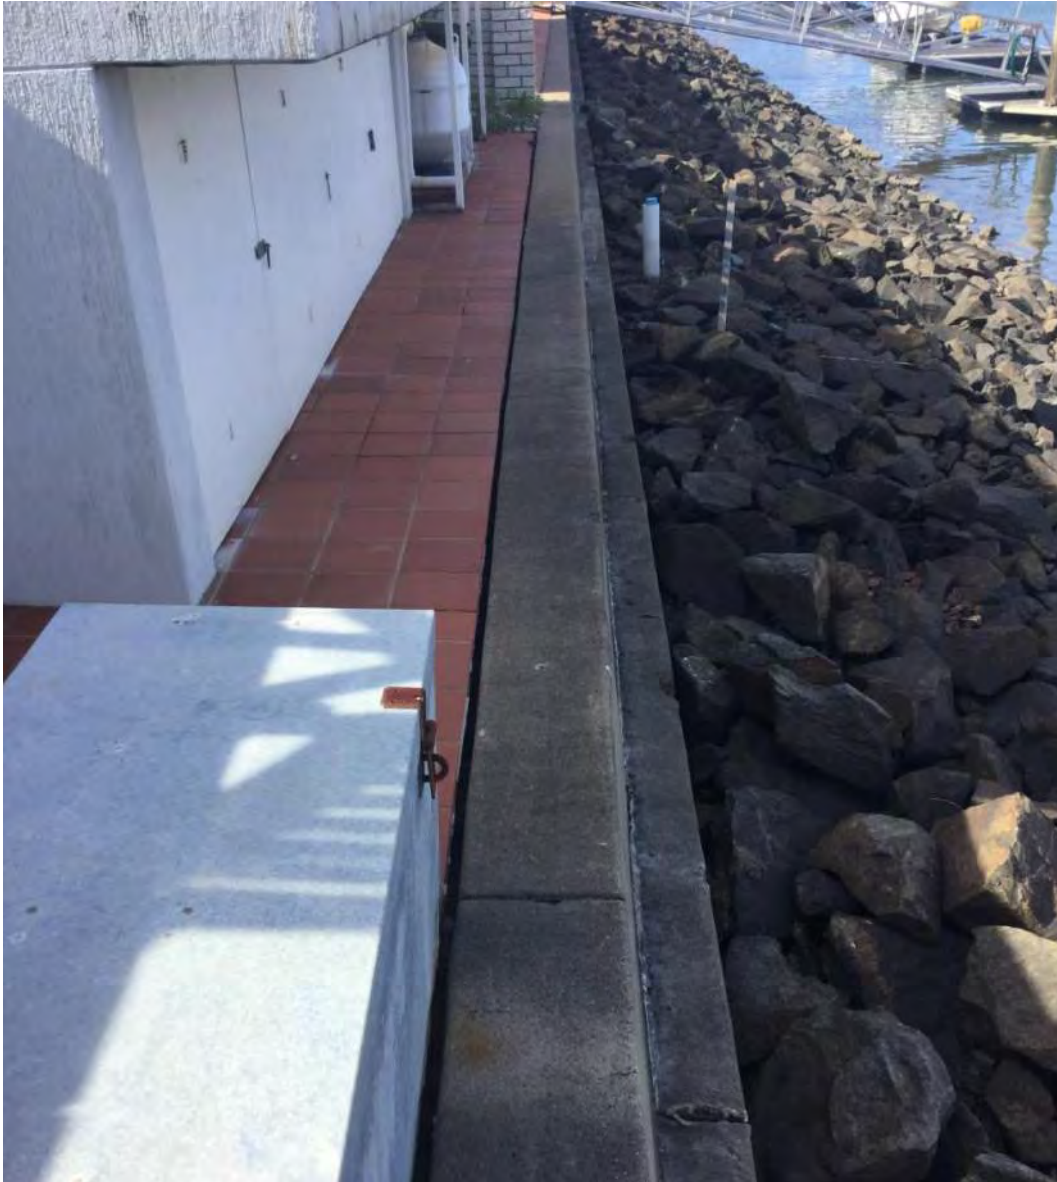
Figure 32: 15 Sternlight Court - Pre-construction general view from pontoon walkway looking north, dated 25 January 2017

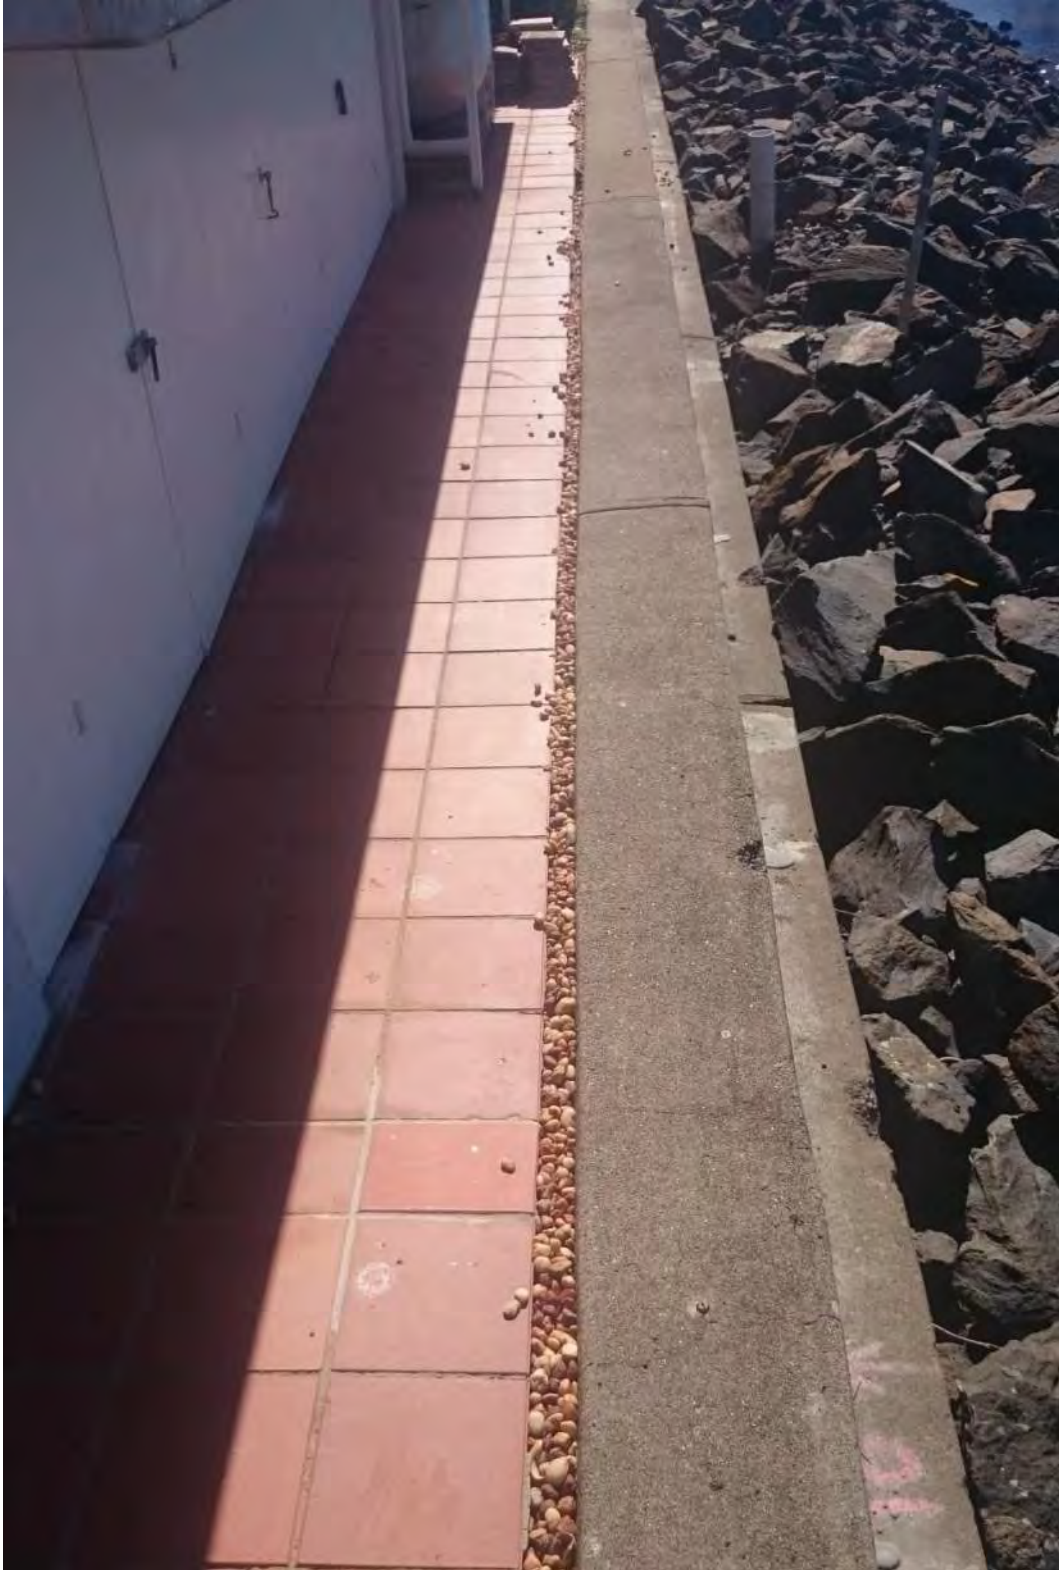
Figure 33: 15 Sternlight Court - Post-construction general view from pontoon walkway looking north, dated 5 June 2017
