19.6 RABY BAY REVETMENT WALL TRIAL AND REPORT

Raby Bay Repair Trial assessment report

Redland City Council (RCC) has commissioned a project to trial various stabilisation treatment methods to address the history of ongoing revetment wall movement observed within the Raby Bay Canal Estate (located in Cleveland, QLD).

The purpose of this document is to summarise the Repair Trial process and detail the methodology and results of the Repair Trial assessment.

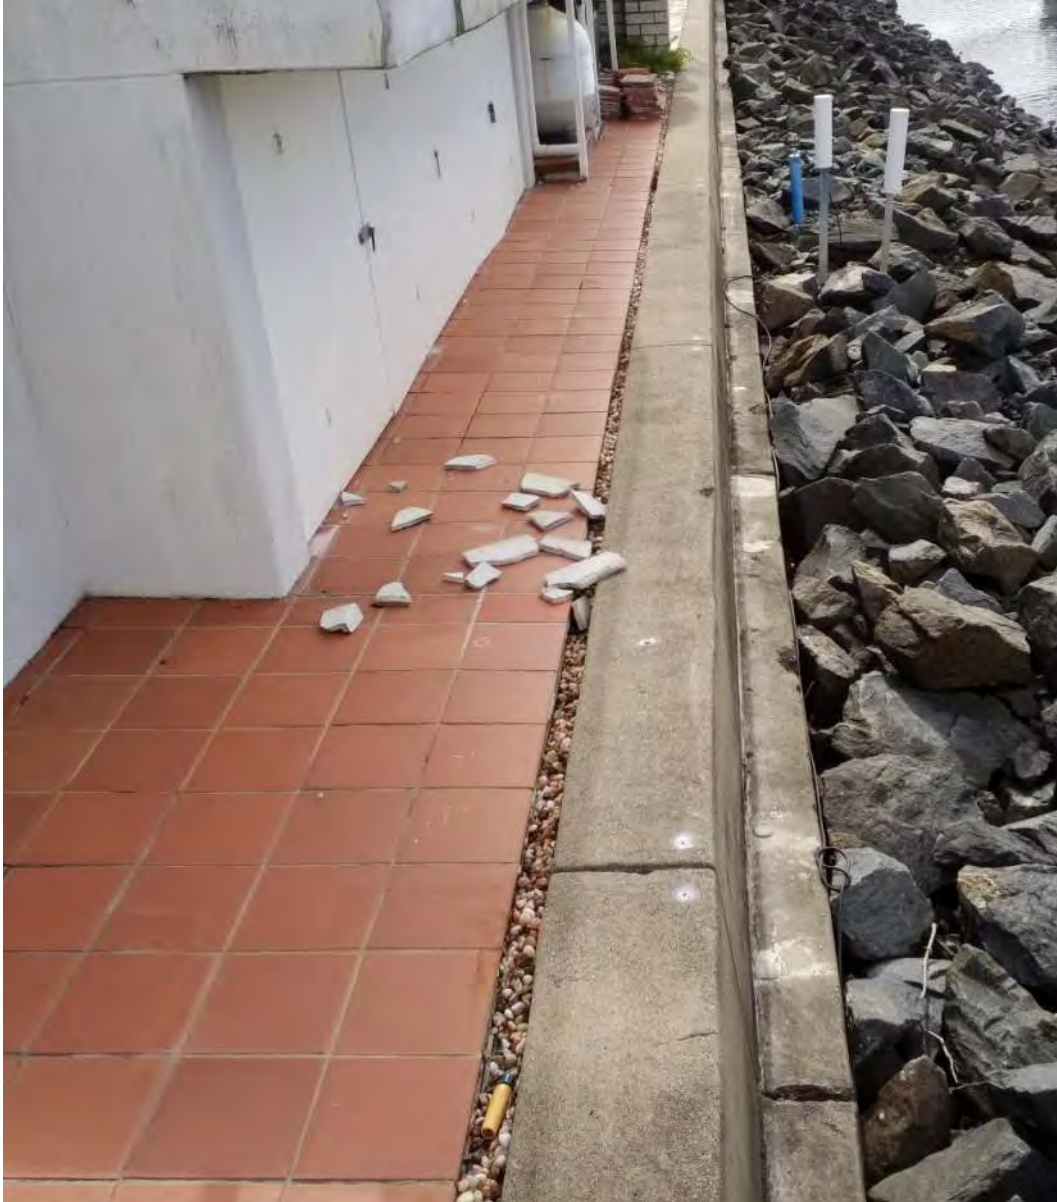
Figure 34: 15 Sternlight Court - Post-construction general view from pontoon walkway looking north, dated 20 June 2018 (from [12])

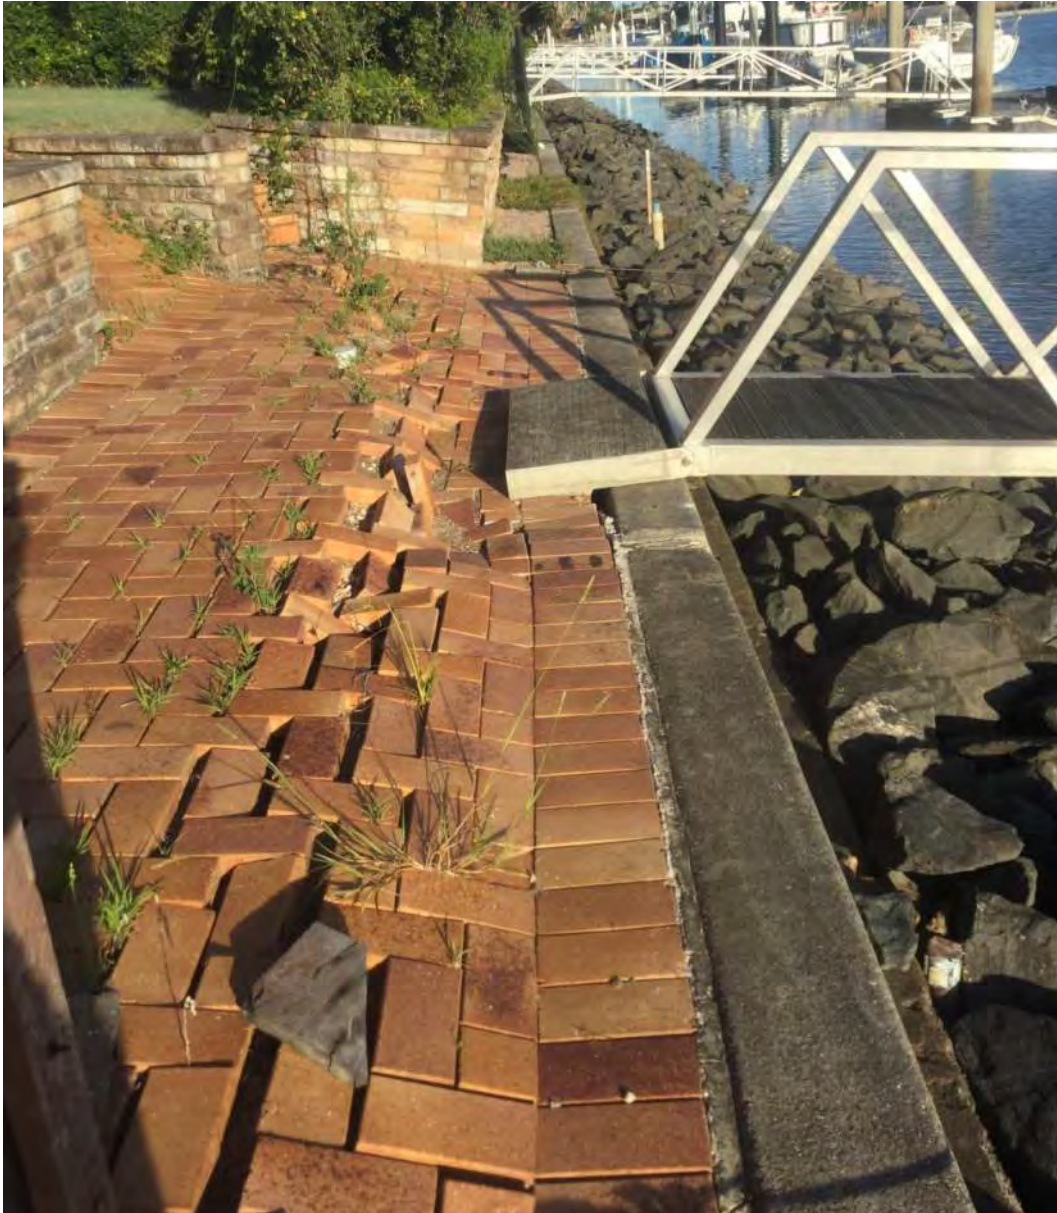
Figure 35: 81 Masthead Drive - Pre-construction general view looking east, dated 25 January 2017

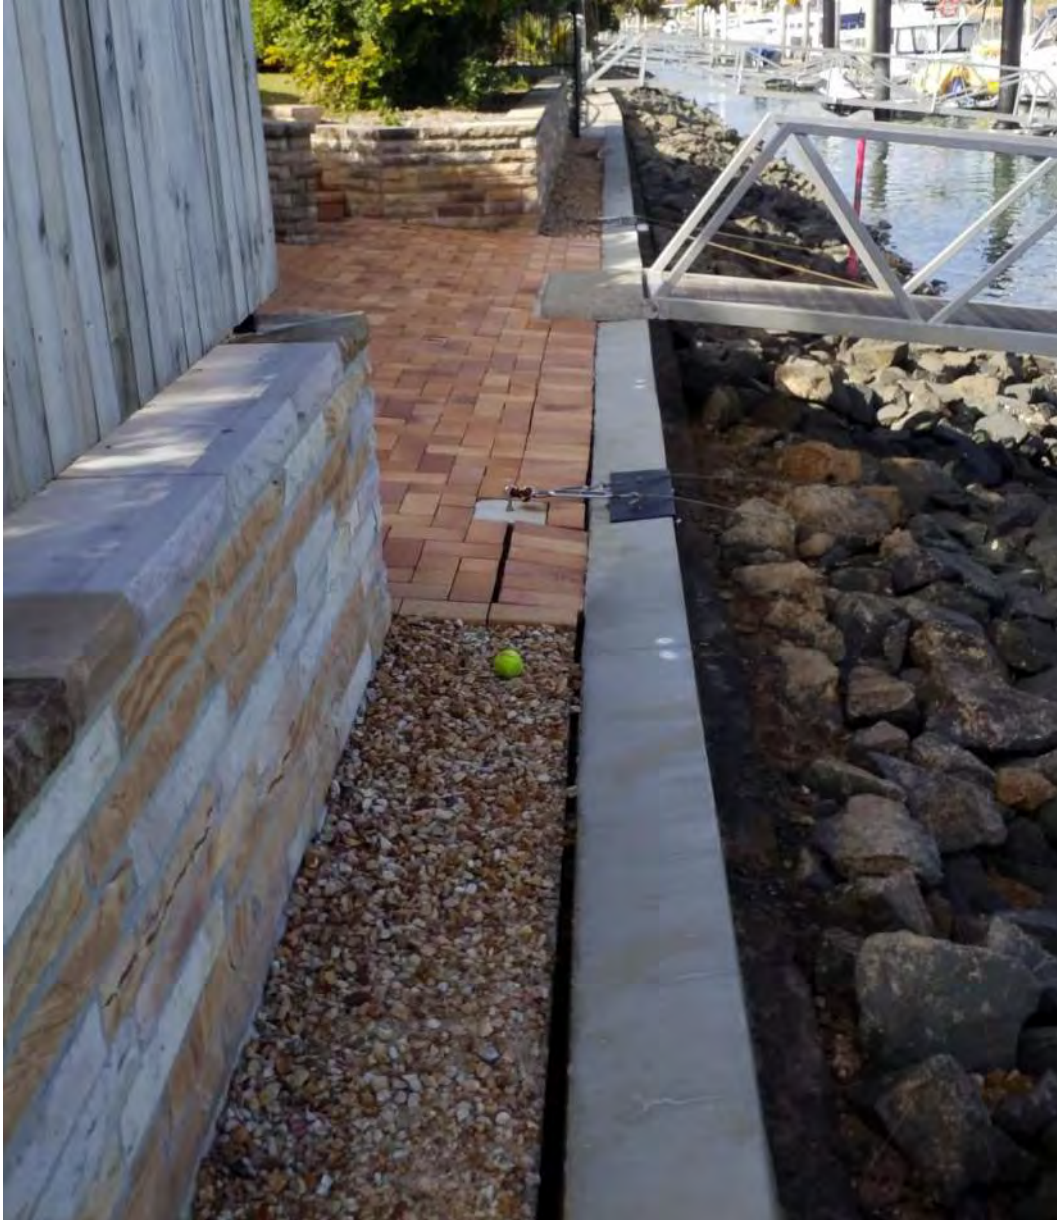
Figure 36: 81 Masthead Drive - Post-construction general view looking east, dated 20 June 2018 (from [12])

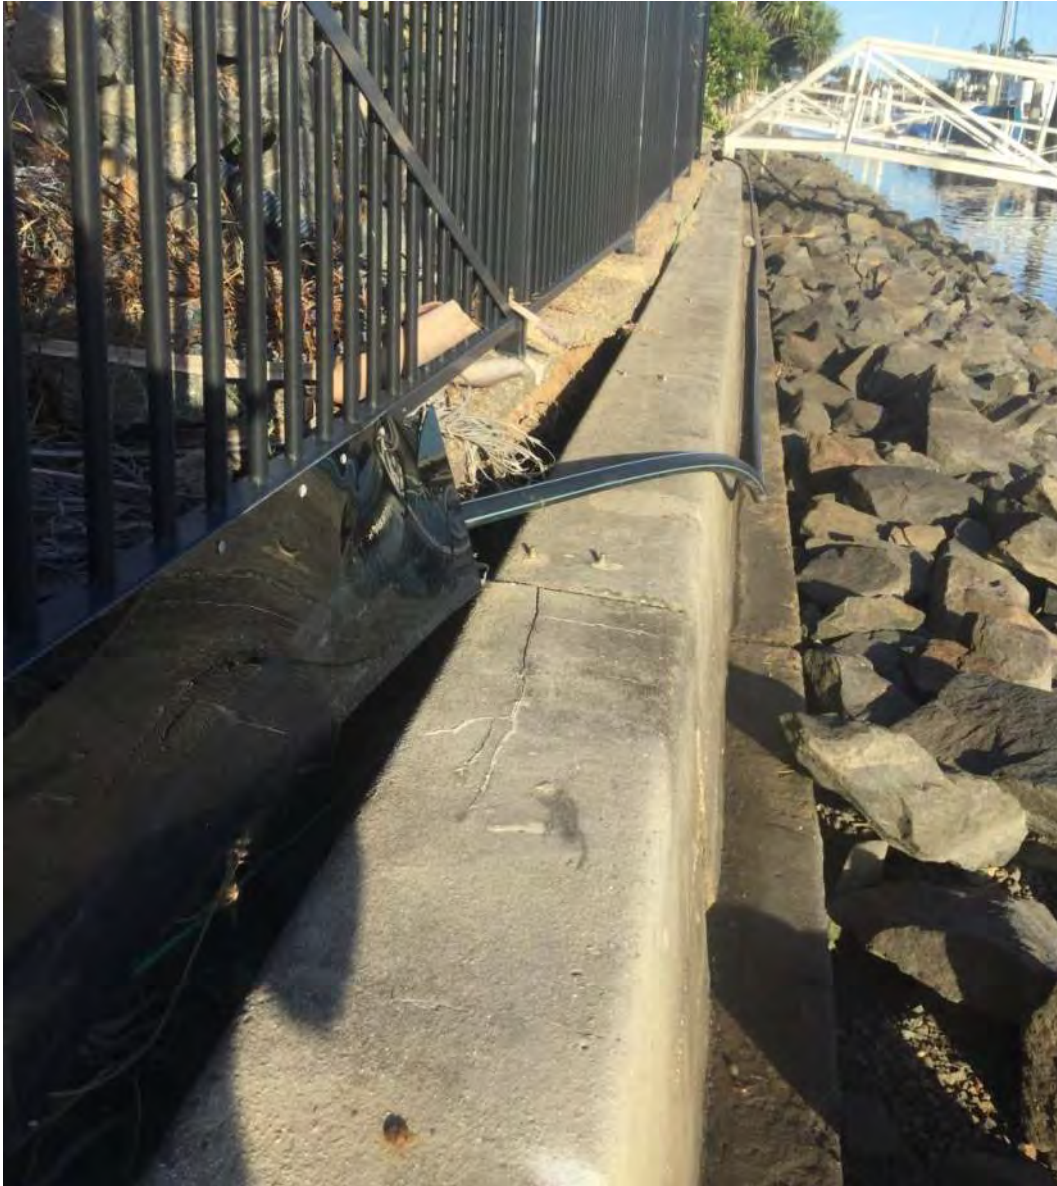
Figure 37: 83 Masthead Drive - Pre-construction general view looking east, dated 25 January 2017

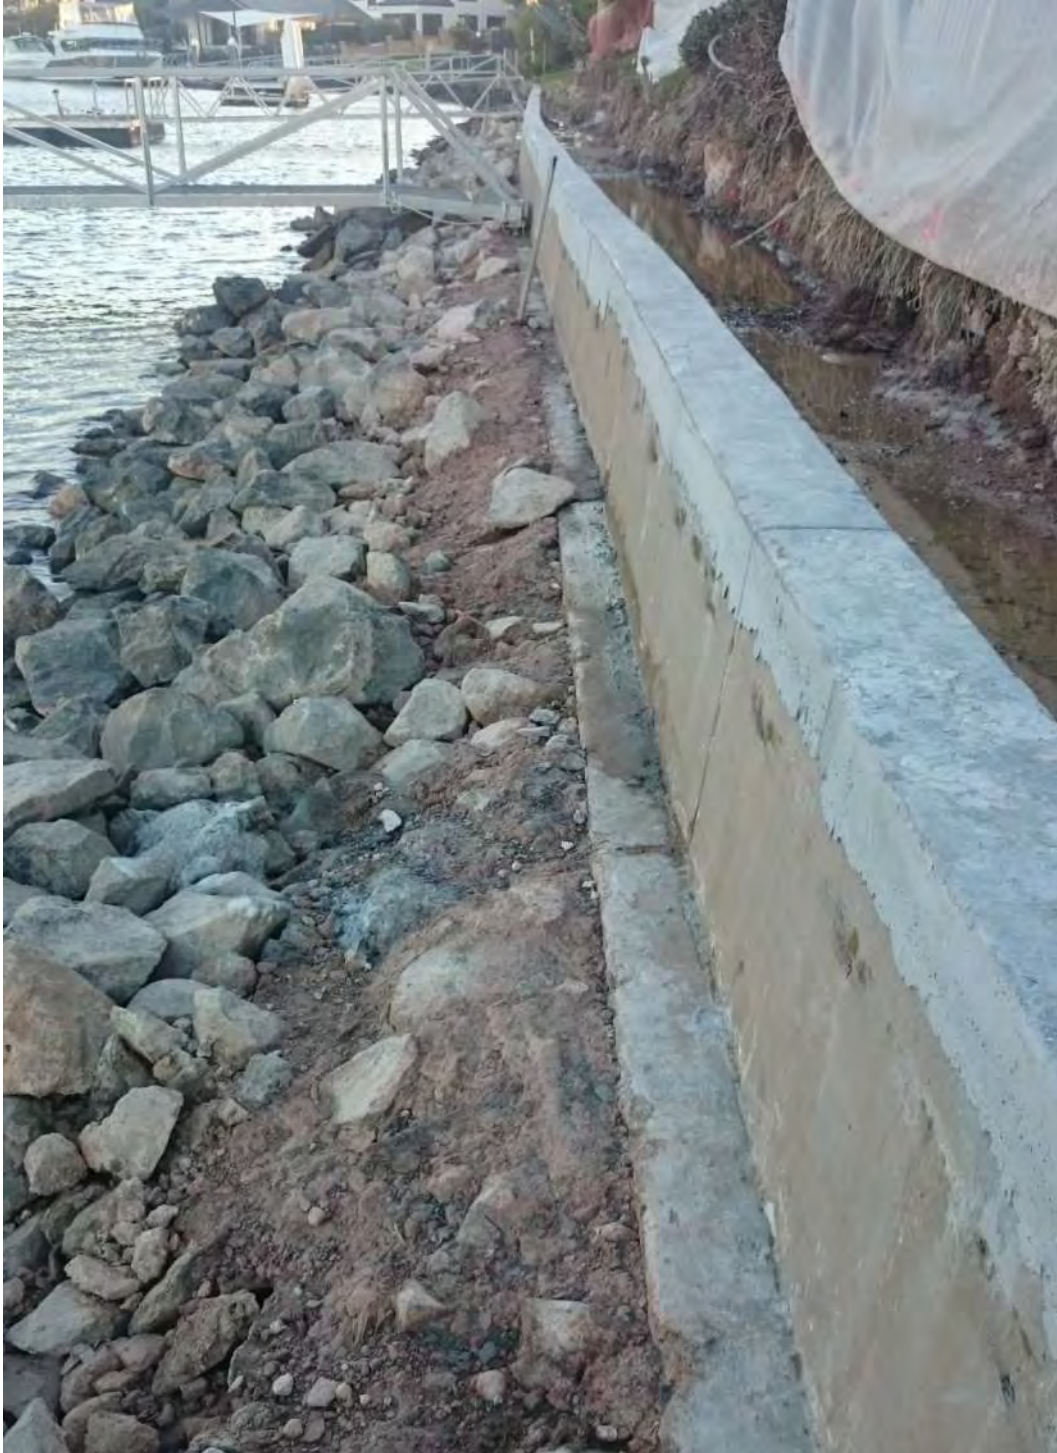
Figure 38: 83 Masthead Drive – During construction general view from 85 Masthead Drive looking west, dated 20 July 2017

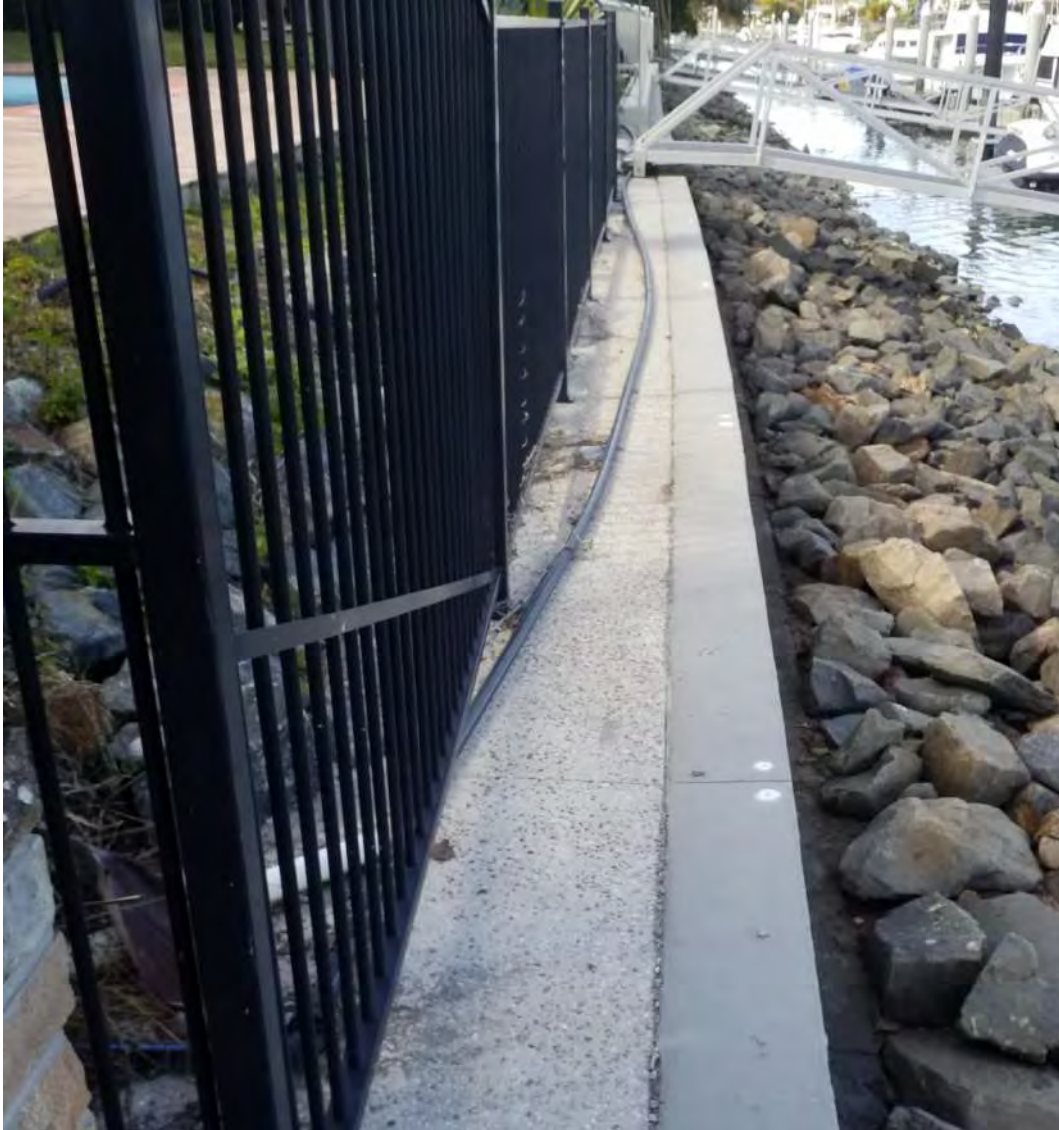
Figure 39: 83 Masthead Drive - Post-construction general view looking east, dated 20 June 2018 (from [12])

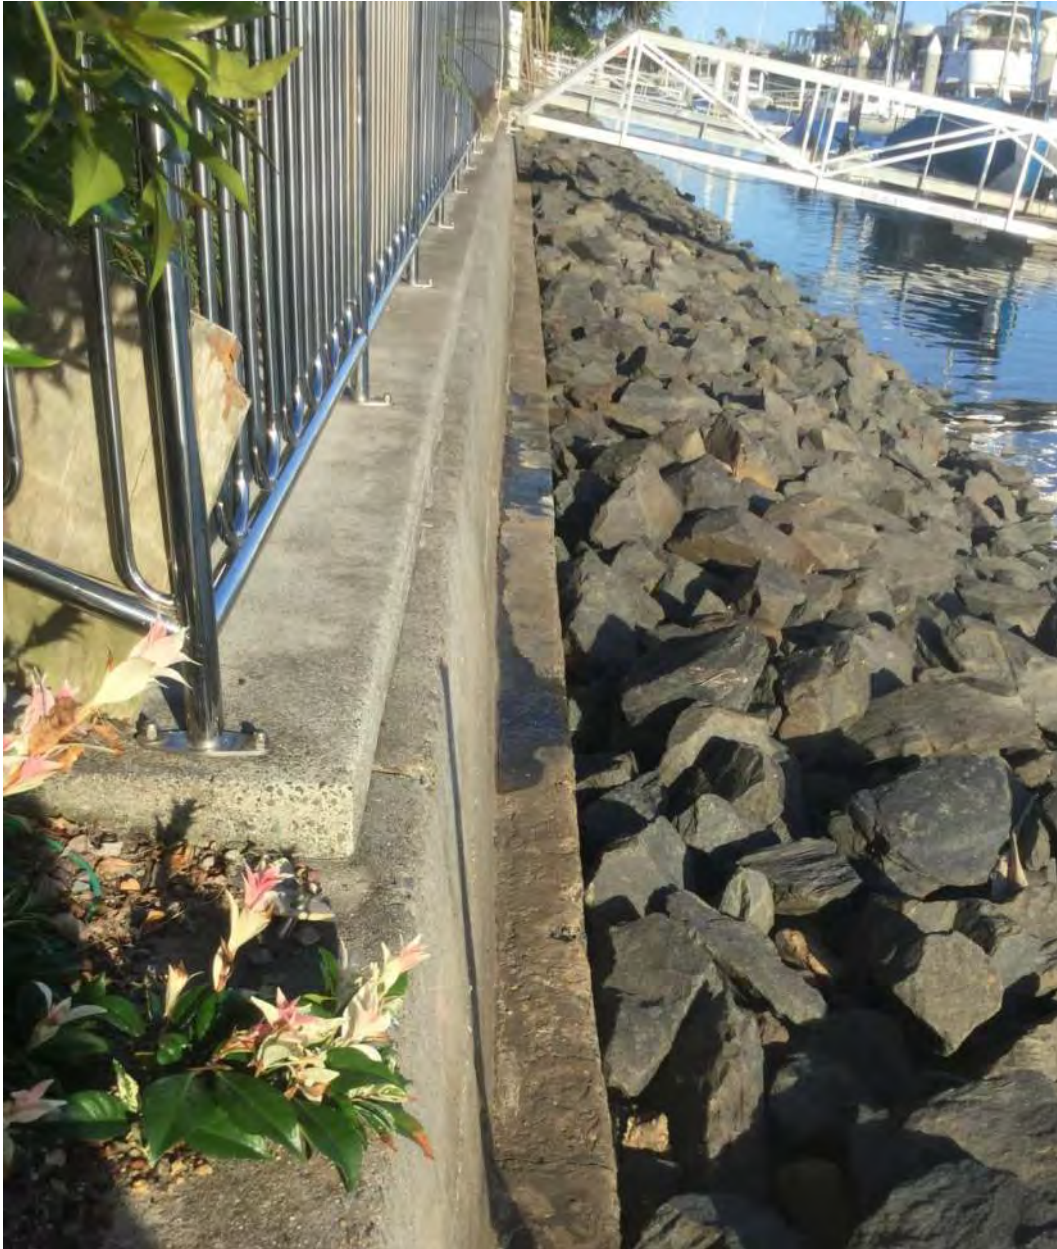
Figure 40: 85 Masthead Drive - Pre-construction general view looking east, dated 25 January 2017

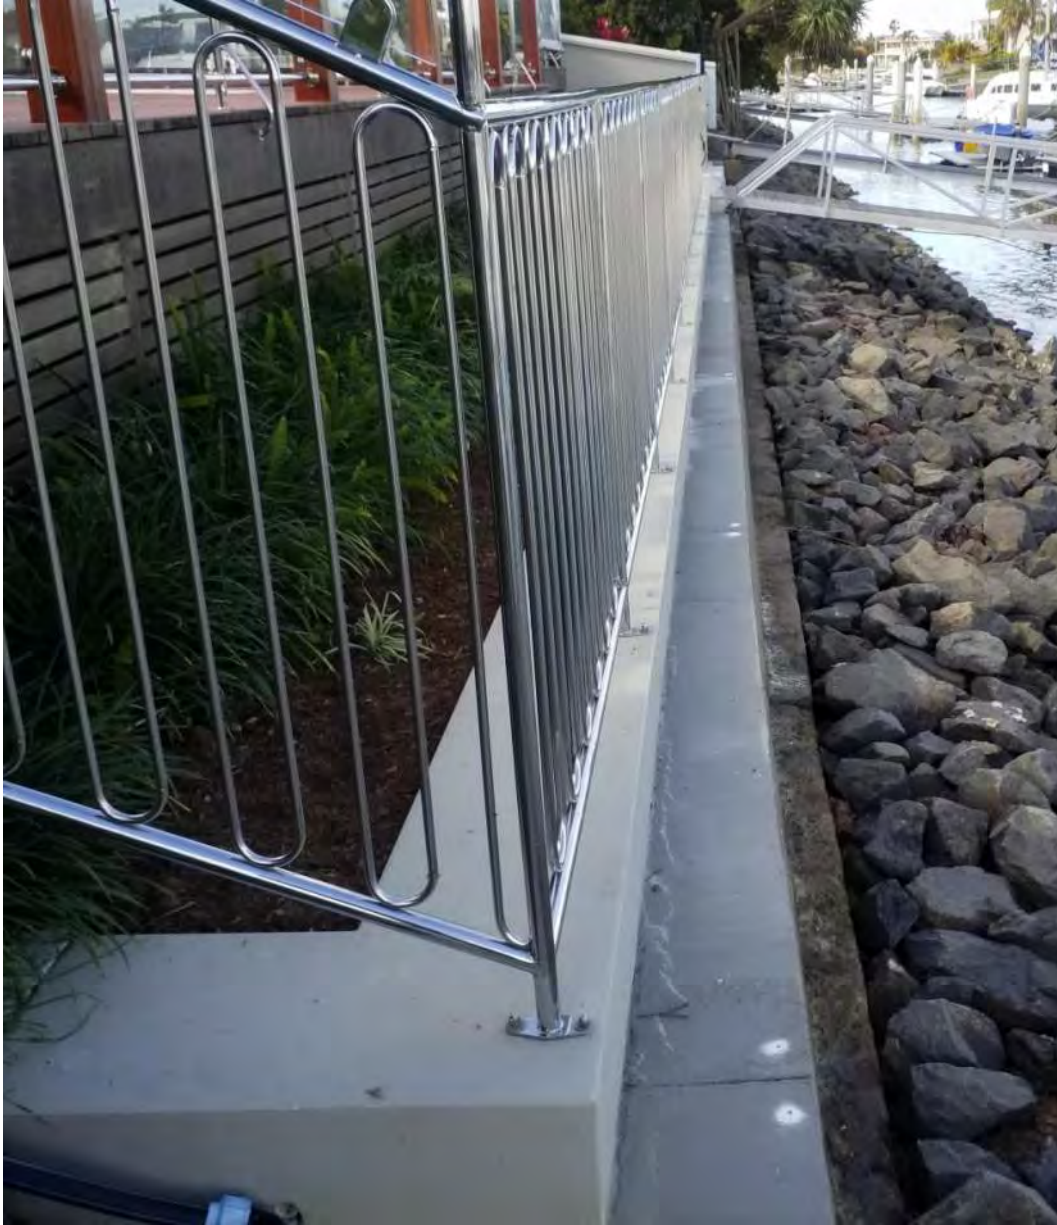
Figure 41: 85 Masthead Drive - Post-construction general view looking east, dated 20 June 2018 (from [12])
