OLD CLEVELAND ROAD EAST OPTIONS

The purpose of this report is to seek Council's direction on a preferred option for preserving the historic values of 302 Old Cleveland Road East, Birkdale property, described as Lot 2 on RP211270.

The purpose of this inspection was to ascertain the general structural condition of the four buildings with reference to visually observed defects and to subsequently assess the scope (both method and economics) of rectification works required. Investigations were also undertaken into what would be structurally required to allow the buildings to be relocated from the site.

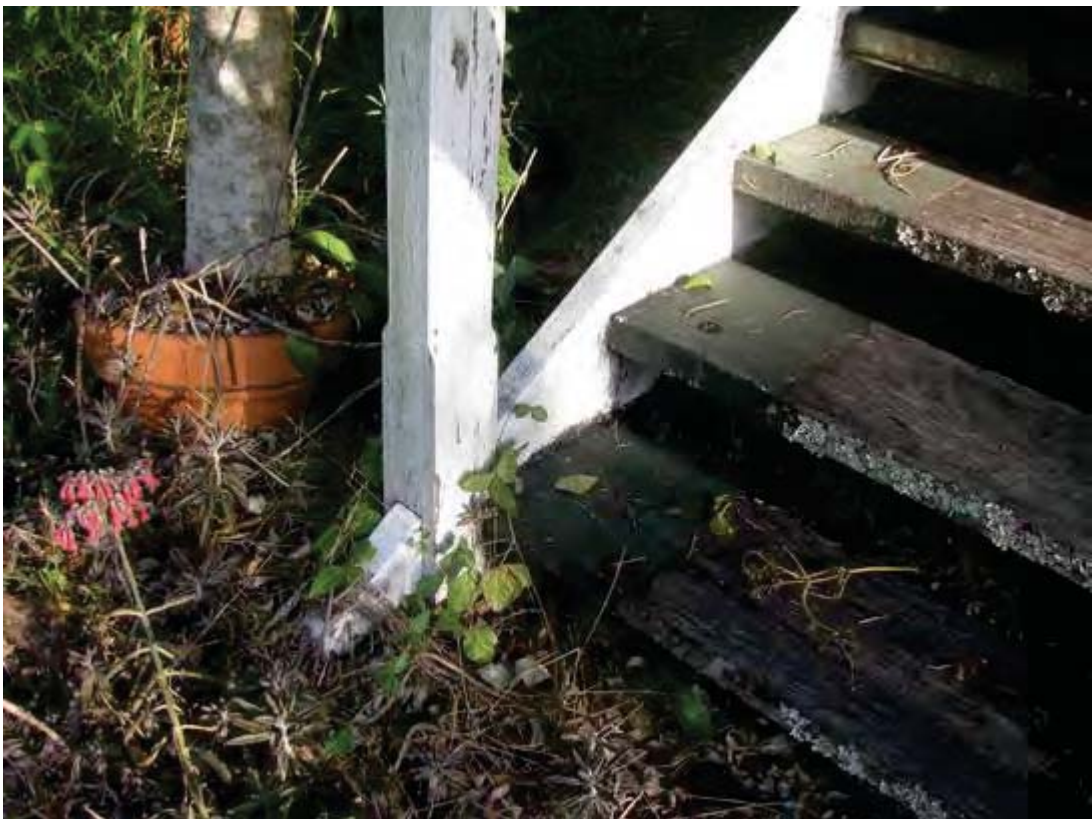
Photograph 4 - Residence steps

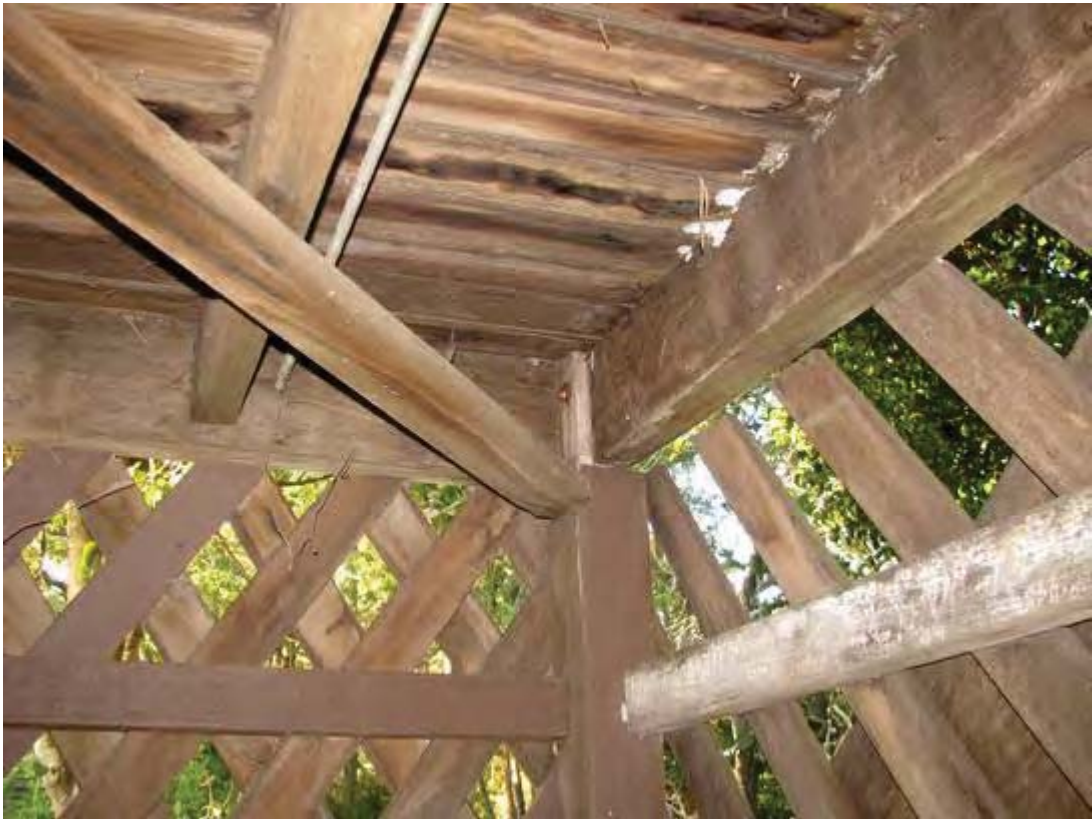
Photograph 9 - Residence verandah subfloor

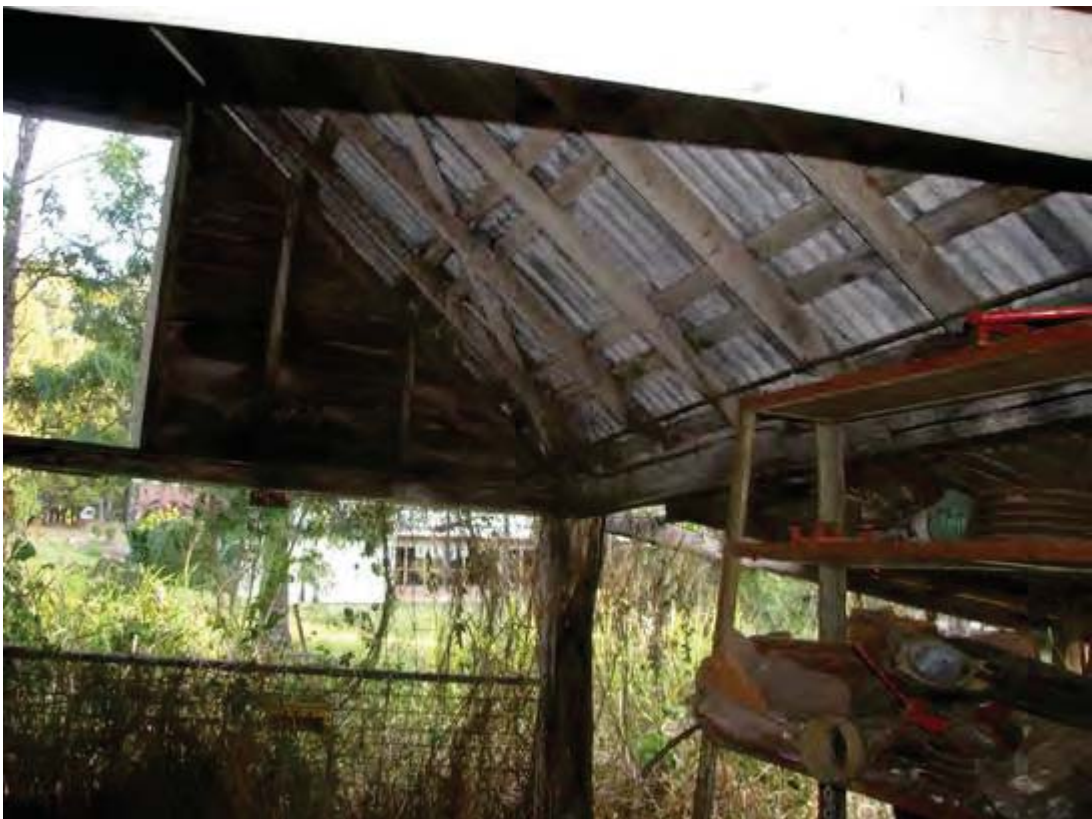
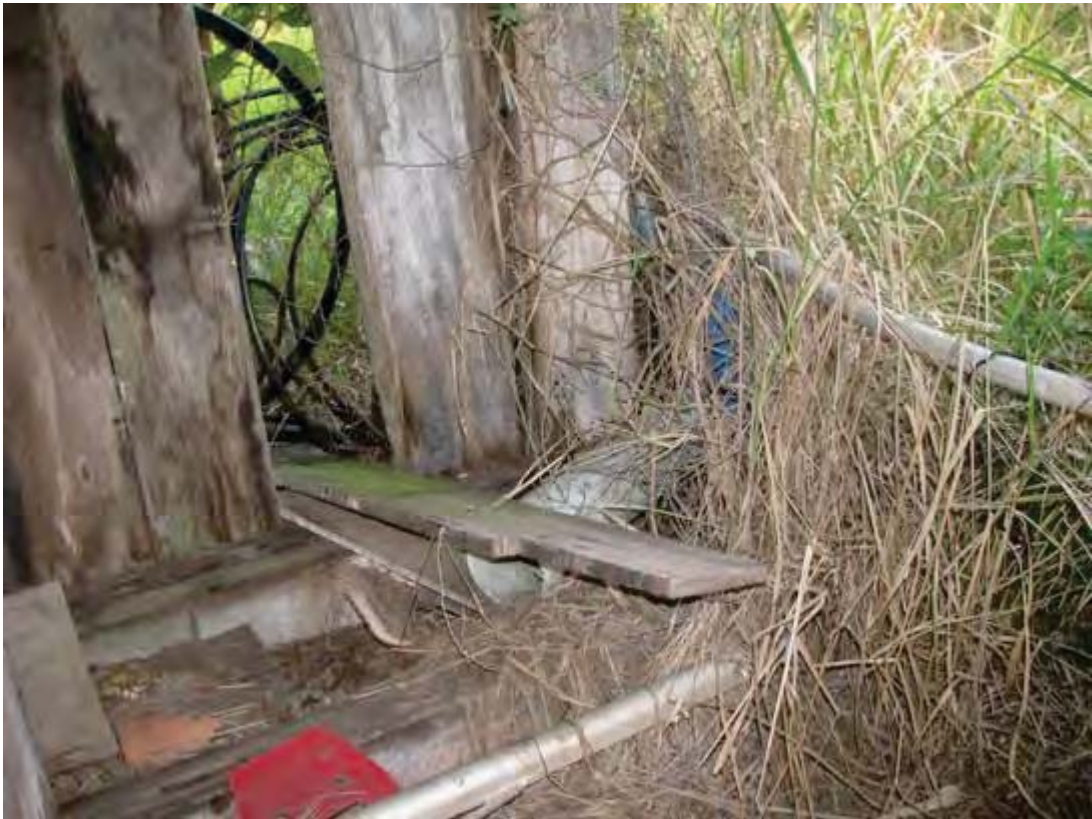
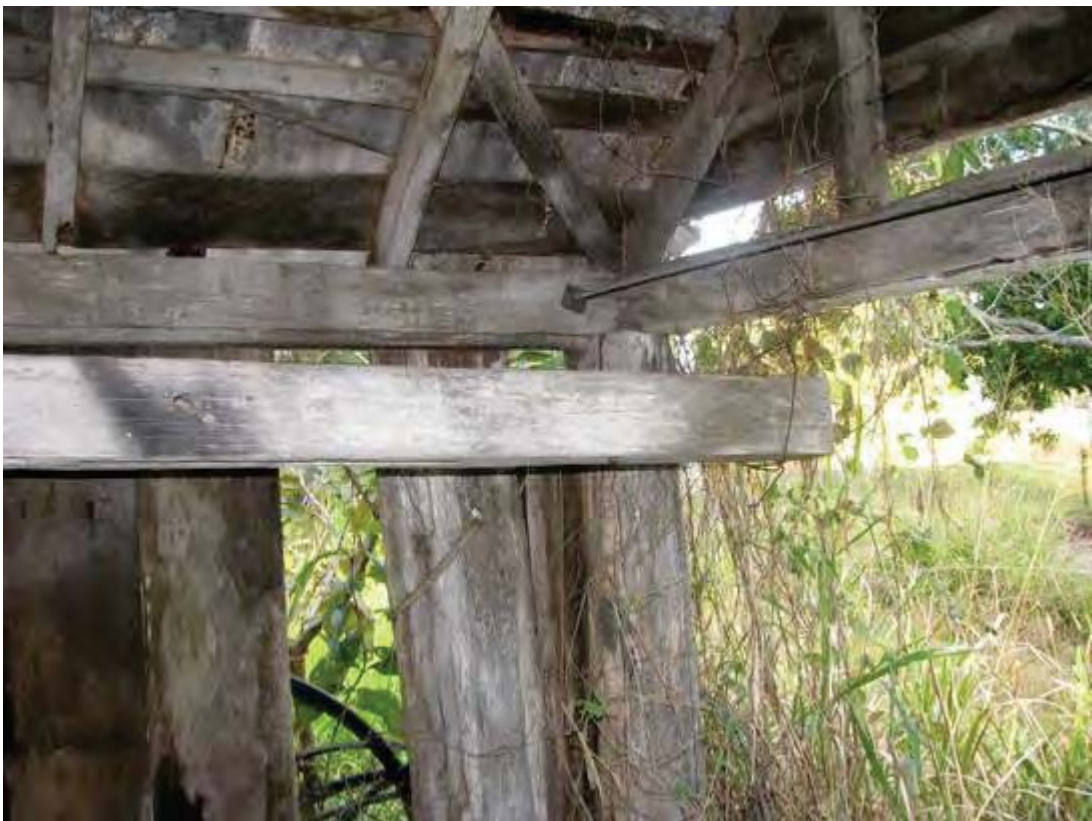
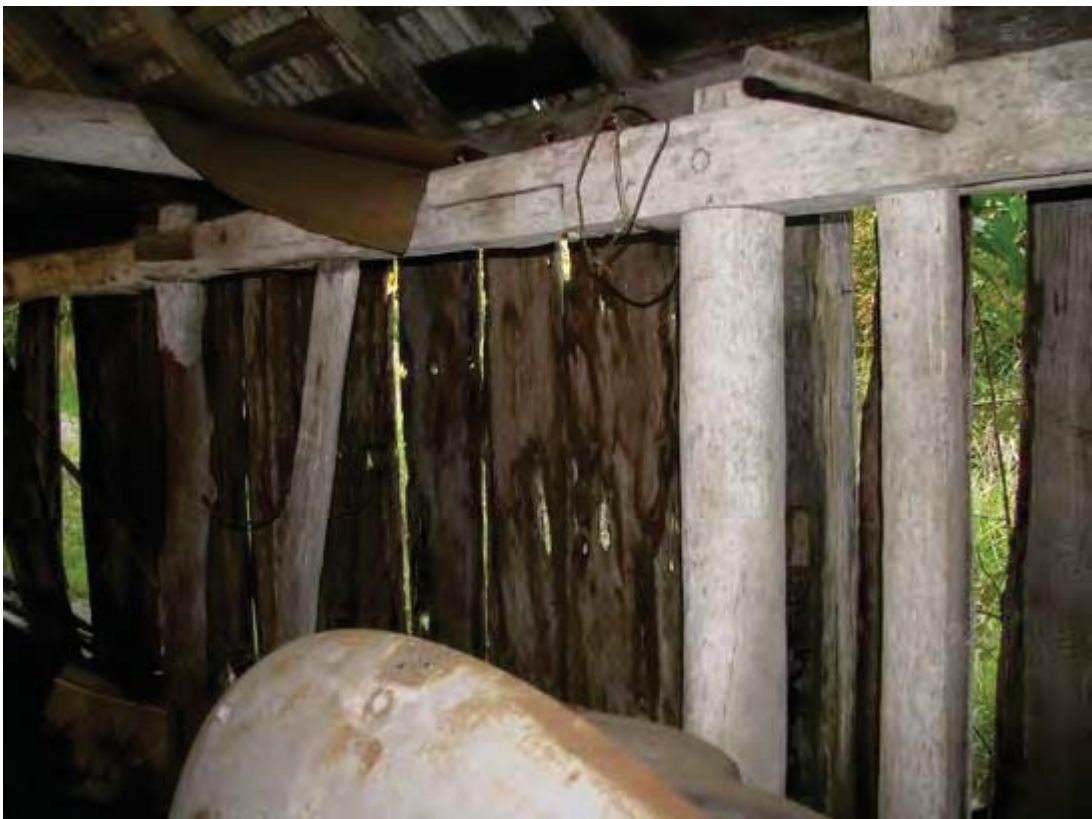
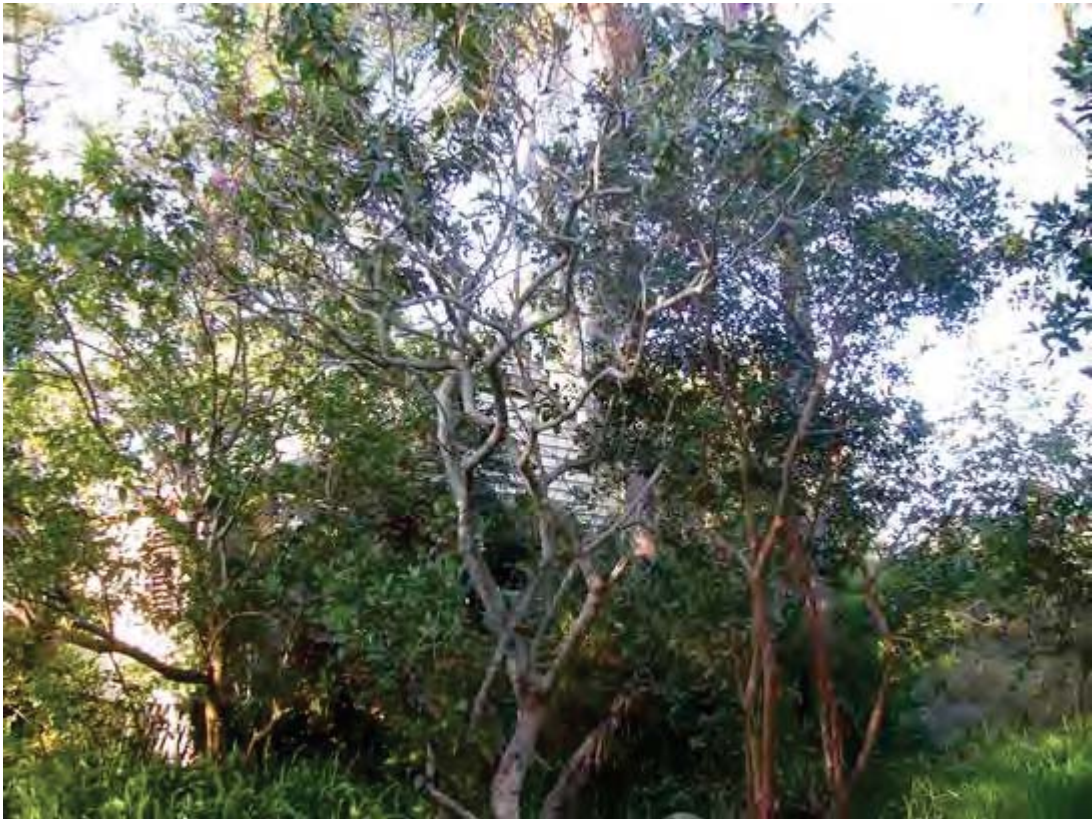
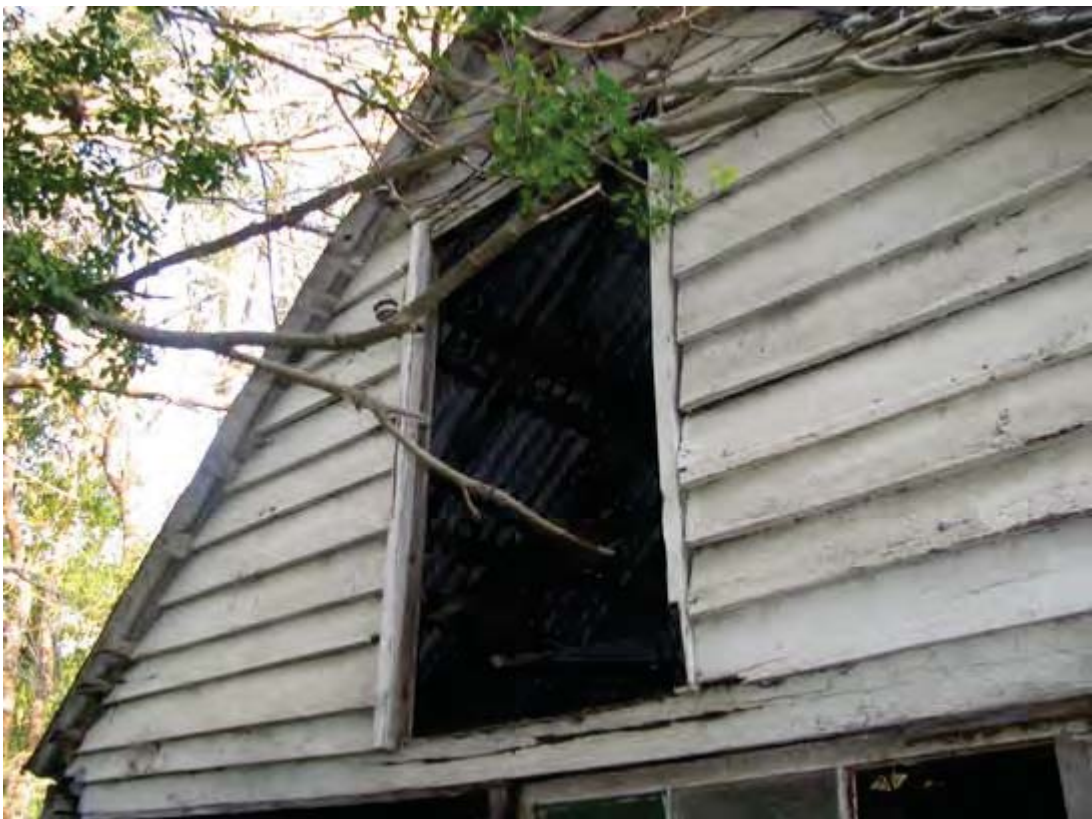
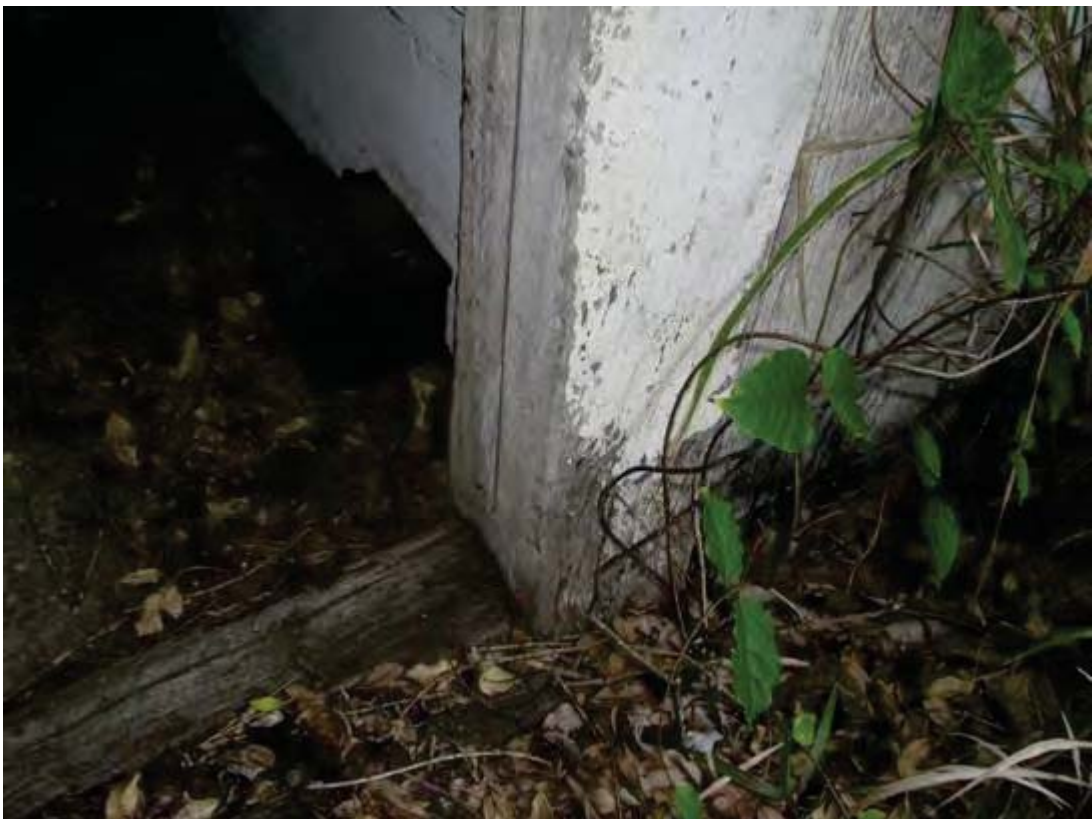
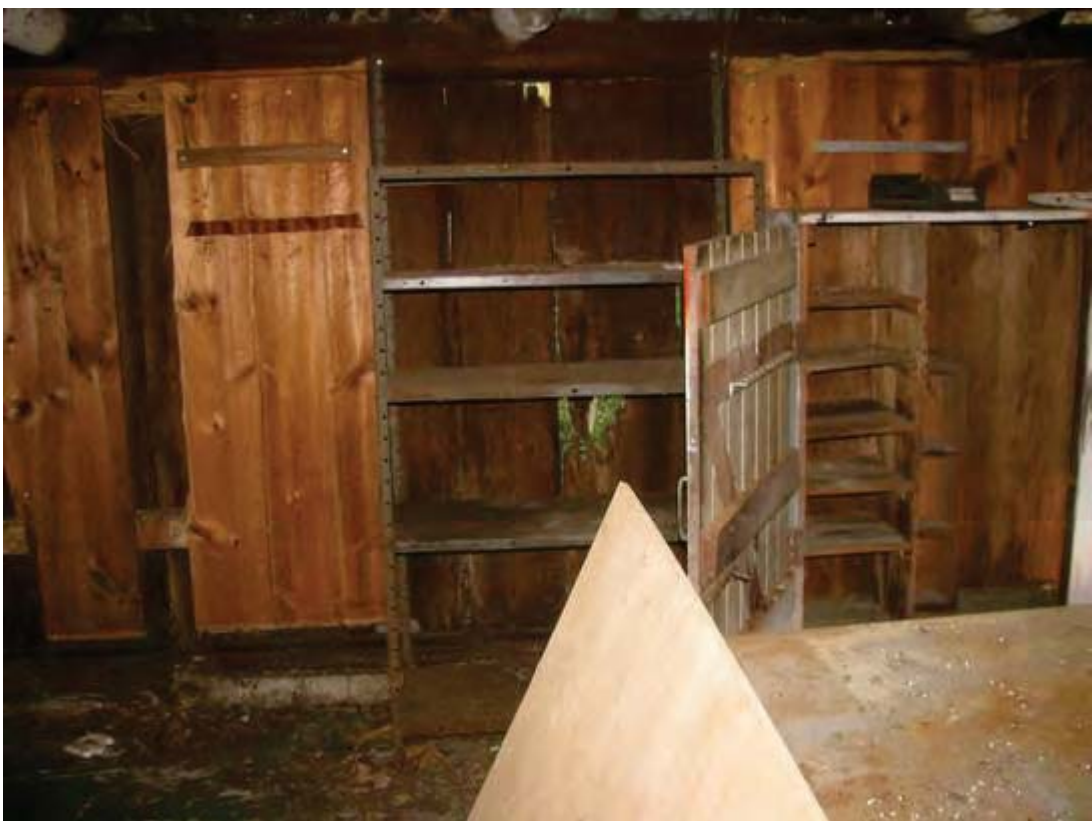
Much of the building is supported by rotten or termite damaged timbers. There is also very little positive bracing or tiedown and many of the timbers are undersized.

As a result of the degradation and the form of construction of the dairy, it is considered to be potentially unstable and may collapse in a high wind load event.

Photograph 62 - Dairy

Any repairs to this building would entail constructing additional internal and/or external supporting frameworks to provide the necessary stability to the remaining existing timbers.

Relocation of this structure would only be possible by disassembling it under controlled, safe conditions and then reassembling any intact parts whilst replacing any damaged parts and installing additional bracing, framing and tiedown.

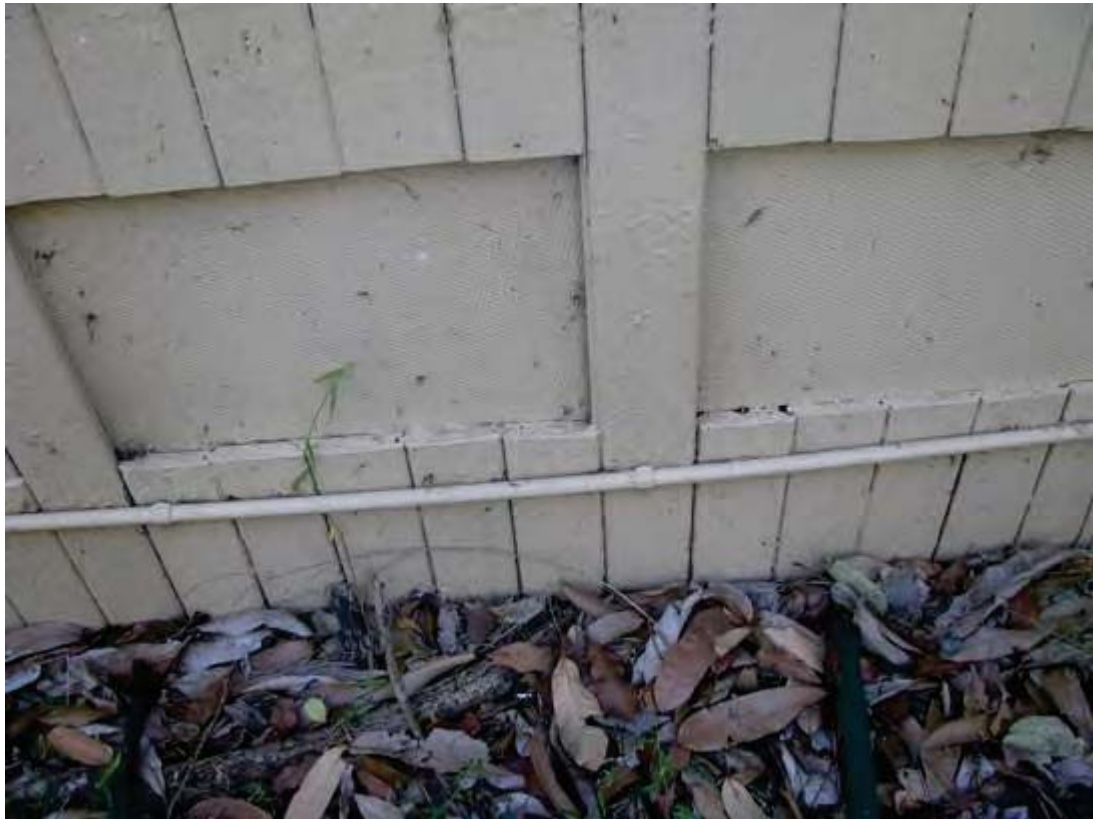
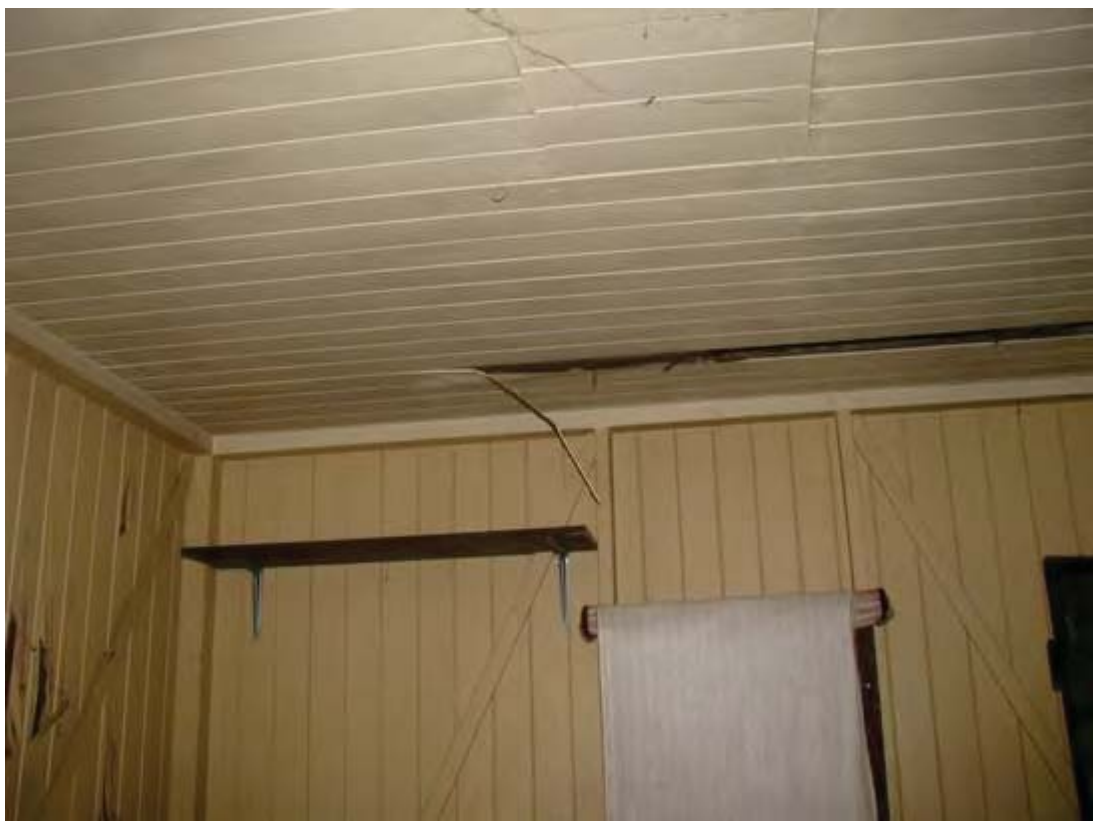
It is clear that the creamery has had very little, if any, ongoing maintenance and there are substantial parts that have been affected by termites and rot. Any repairs to this building would entail replacing the degraded timber and constructing additional internal and/or external supporting frameworks to provide the necessary stability to the remaining existing timbers.

Photograph 81 - Creamery

Relocation of the entire structure is feasible using normal house transporting techniques following removal and/or replacement of any severely degraded elements.

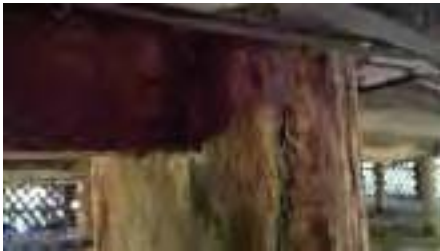
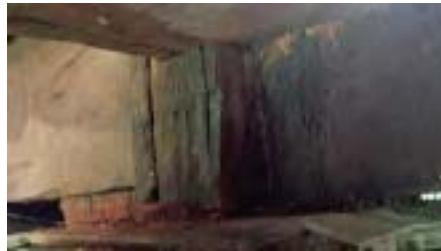
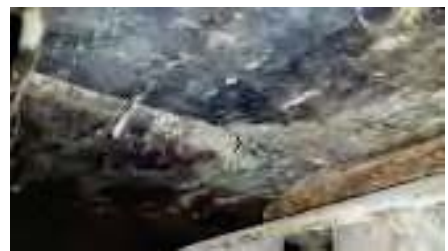
Timber Piers x 6

2.4 Termite damage and/or workings were found mainly in **but not limited to**: see below.

Whilst we are not builders, the termite damage appears to be:- **extensive to severe**. See Clause 4 on page 1. If a treatment proposal is attached then note areas marked on the sketch (mud map) for more information on areas of damage and activity.

2.7 Subterranean termite treatment recommendation: A suitable management program that accords with AS 3660 against subterranean termites is considered to be **essential**.

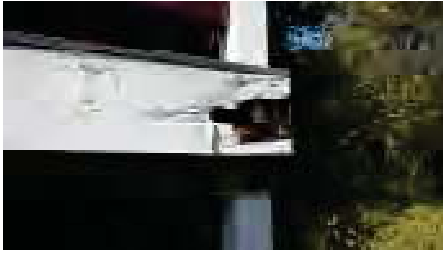
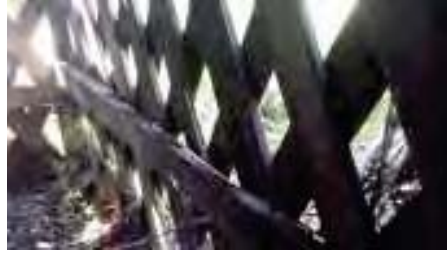
2.9 Wood rot: At the time of the inspection was visible evidence of wood decay fungi (rot) found? **Yes**

Evidence was found in many of the wood structures (not all have been mentioned in this report). Wood decay fungi are conducive to subterranean termites. You should consult a builder or other building expert to find out what must be carried out to prevent further decay (repairing of drainage, leaks and/or sealing the timber) and to repair the damage.
