# Fact Sheet

## Management of turf and salinity of soil on Council owned land

## A Case Study – Raby Bay Foreshore

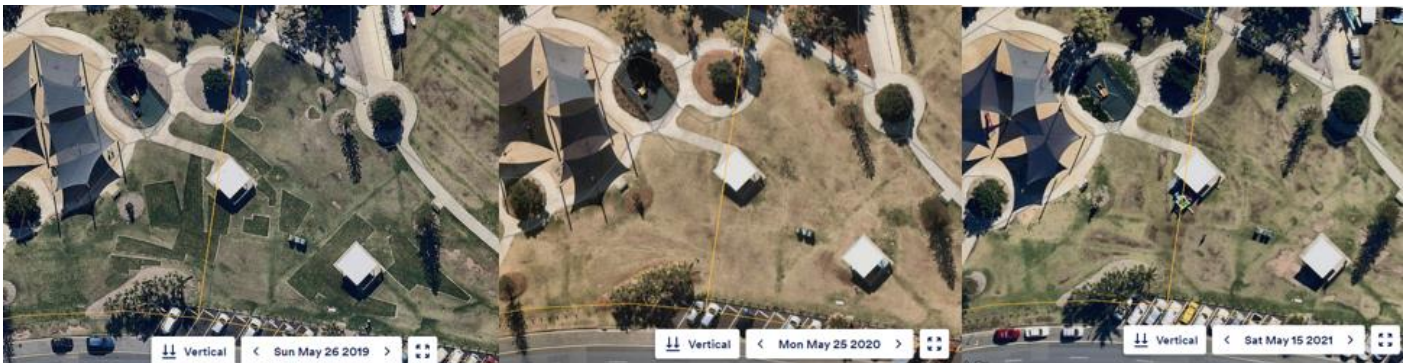
*Aerial view of Raby Bay Foreshore grass quality degradation over a two-year period.*

Raby Bay Foreshore has challenges with soil salinity and healthy turf growth. Over the past 15 years, Council has successfully carried out multiple turf patching efforts. However, in recent years – marked by record-breaking rainfall, turf areas have scalded and perished within a two-year period. This is due to water seeping into the ground after heavy rain, causing the groundwater and the salt stored deep in the soil to rise causing the grass and root systems to scald and die off.

Despite vigilant monitoring initial irrigation and turf replanting, full turf coverage is not always achievable.
