19.6 RABY BAY REVETMENT WALL TRIAL AND REPORT

Raby Bay Repair Trial assessment report

Redland City Council (RCC) has commissioned a project to trial various stabilisation treatment methods to address the history of ongoing revetment wall movement observed within the Raby Bay Canal Estate (located in Cleveland, QLD).

The purpose of this document is to summarise the Repair Trial process and detail the methodology and results of the Repair Trial assessment.

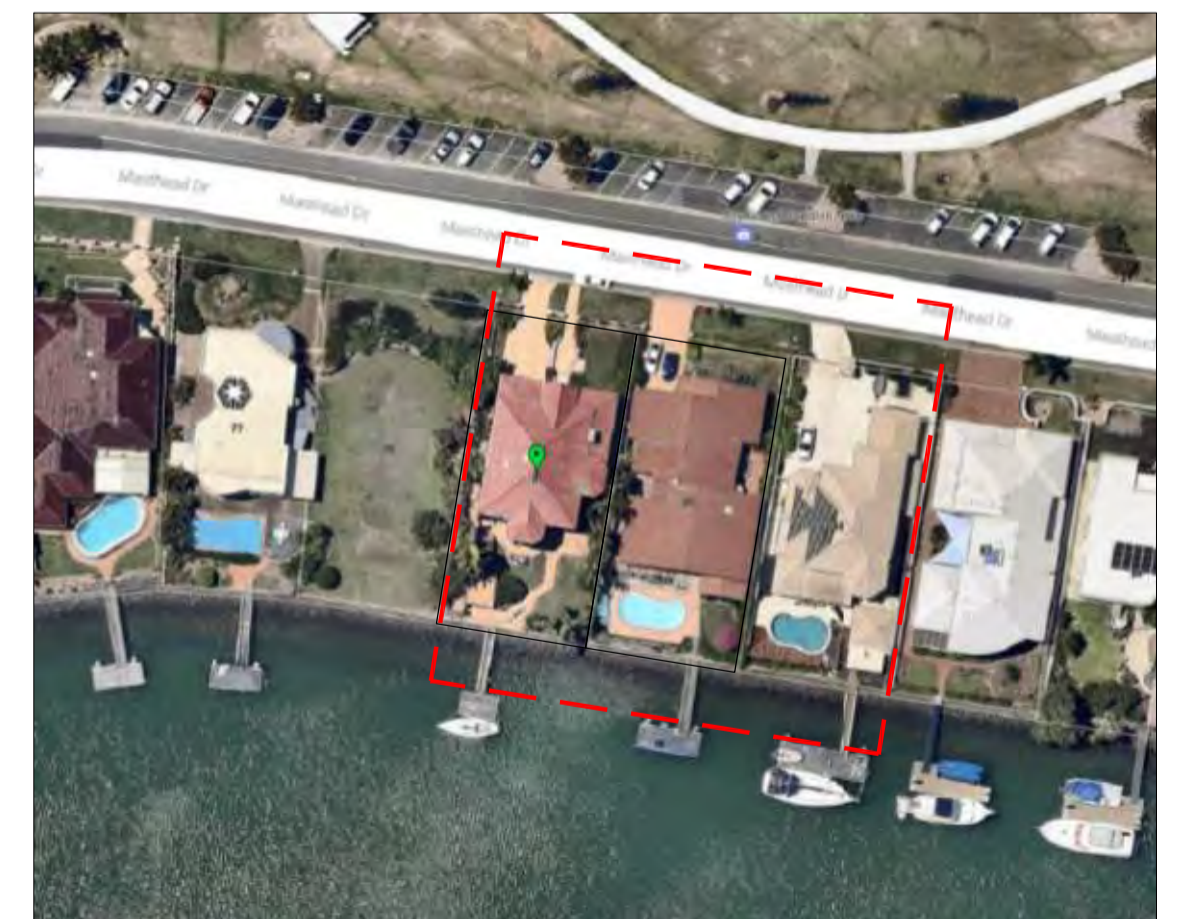
TITLE JET GROUTING STABILISATION WORKS LAYOUT		
SCALE 1:100 (A1)	DRAWING No 5040198-DD-06	REV 0

38 OUT OF X40 COLUMNS WERE INSTALLED. LAST 2 COLUMNS ON THE EASTERN SIDE OF 85 MASTHEAD DRIVE WERE NOT INSTALLED DUE TO EXCESSIVE MOVEMENT OF THE REVETMENT WALL.

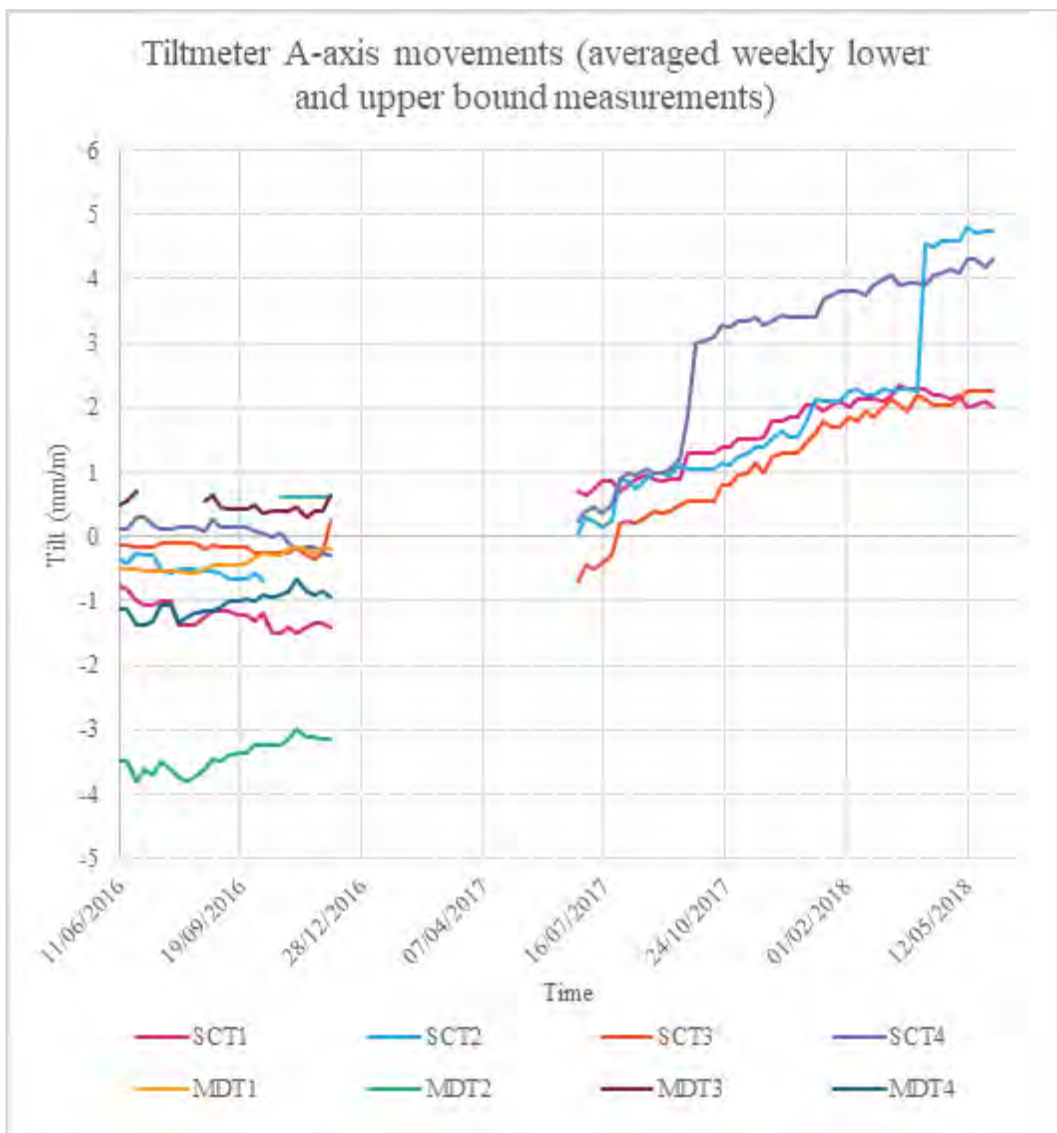
Figure 6: Tiltmeter A-axis measurements with pre-construction on left and post-construction on right (produced from measurements provided in Golder May 2018 monitoring report, ref. [11])

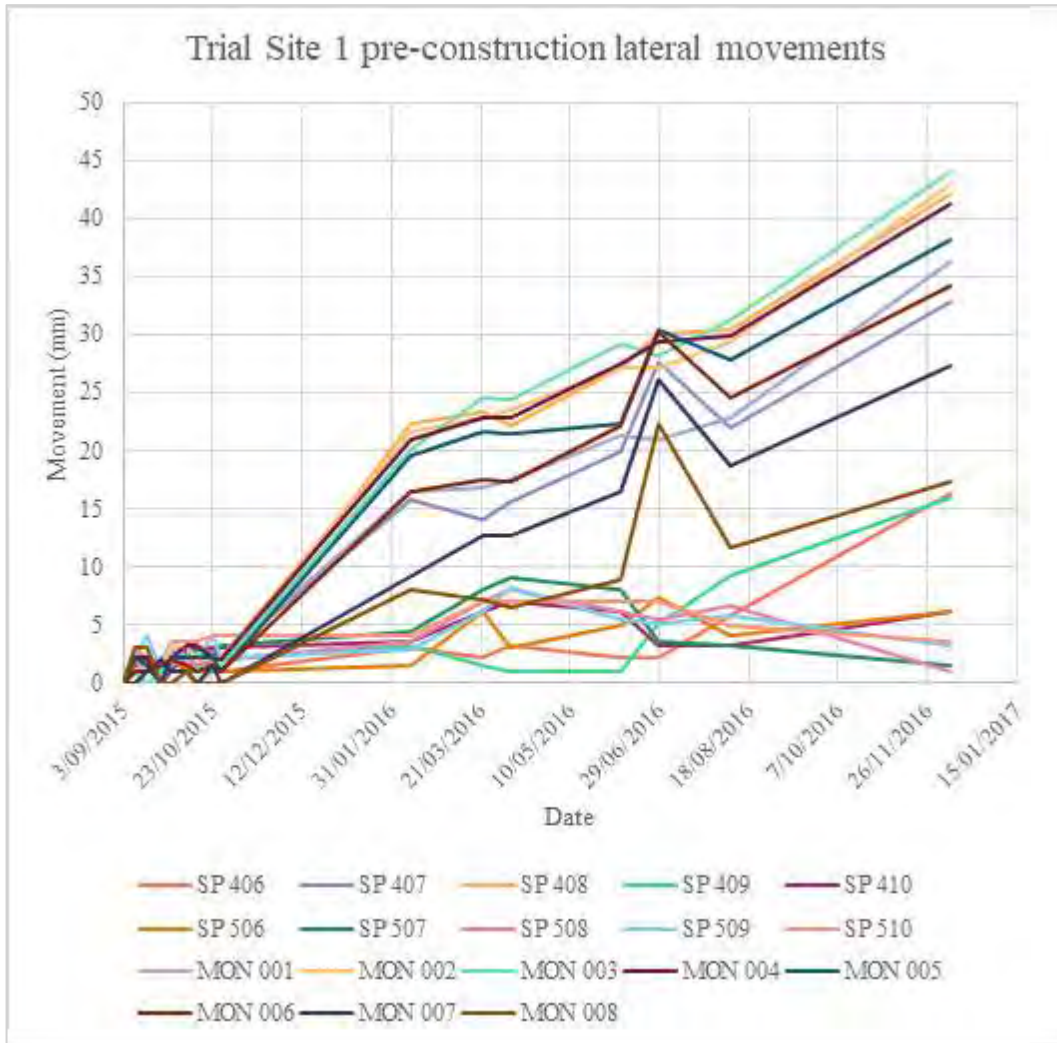
Figure 7: Trial Site 1 pre-construction lateral movements (produced from measurements provided in Golder May 2018 monitoring report, ref. [10], mismeasurements not plotted for clarity)

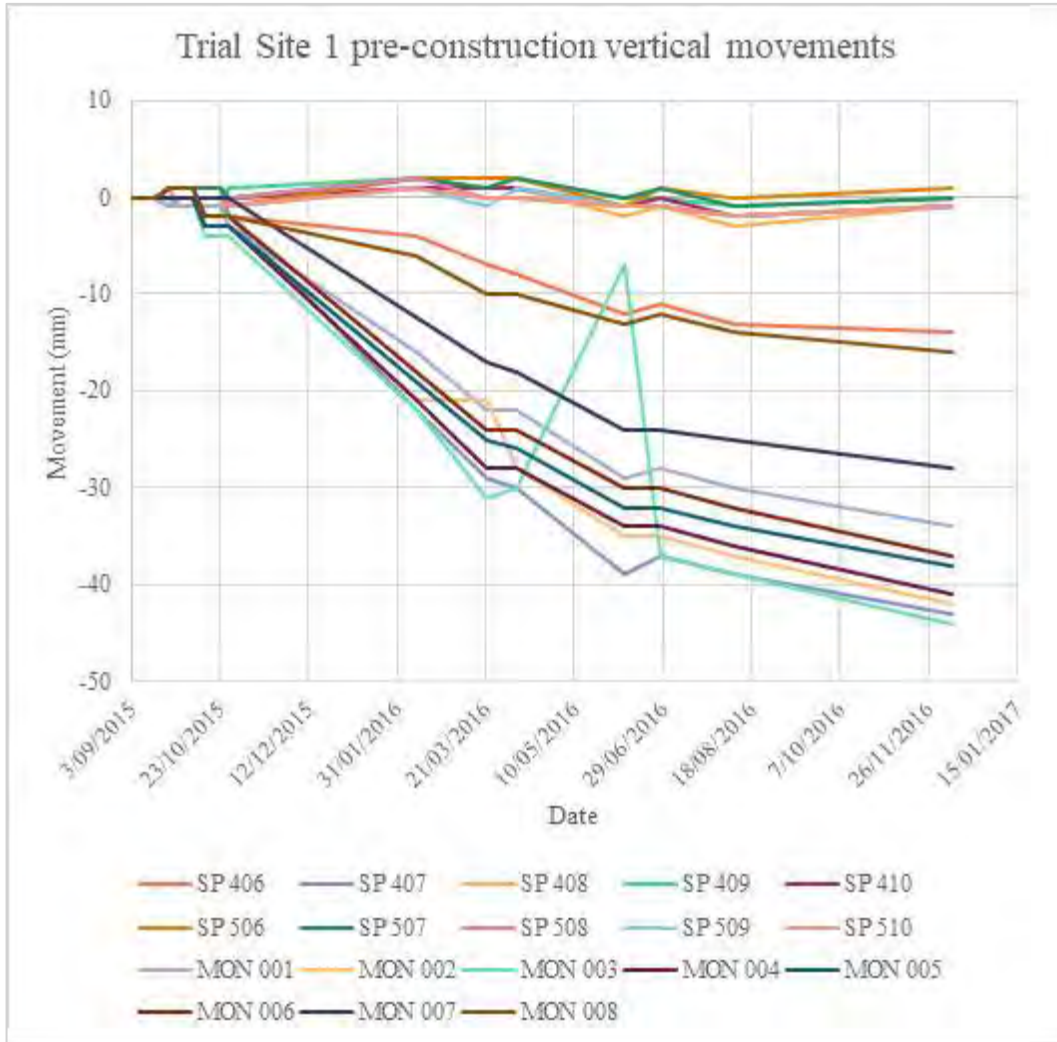
Figure 8: Trial Site 1 pre-construction vertical movements (produced from measurements provided in Golder May 2018 monitoring report, ref. [10], mismeasurements not plotted for clarity)

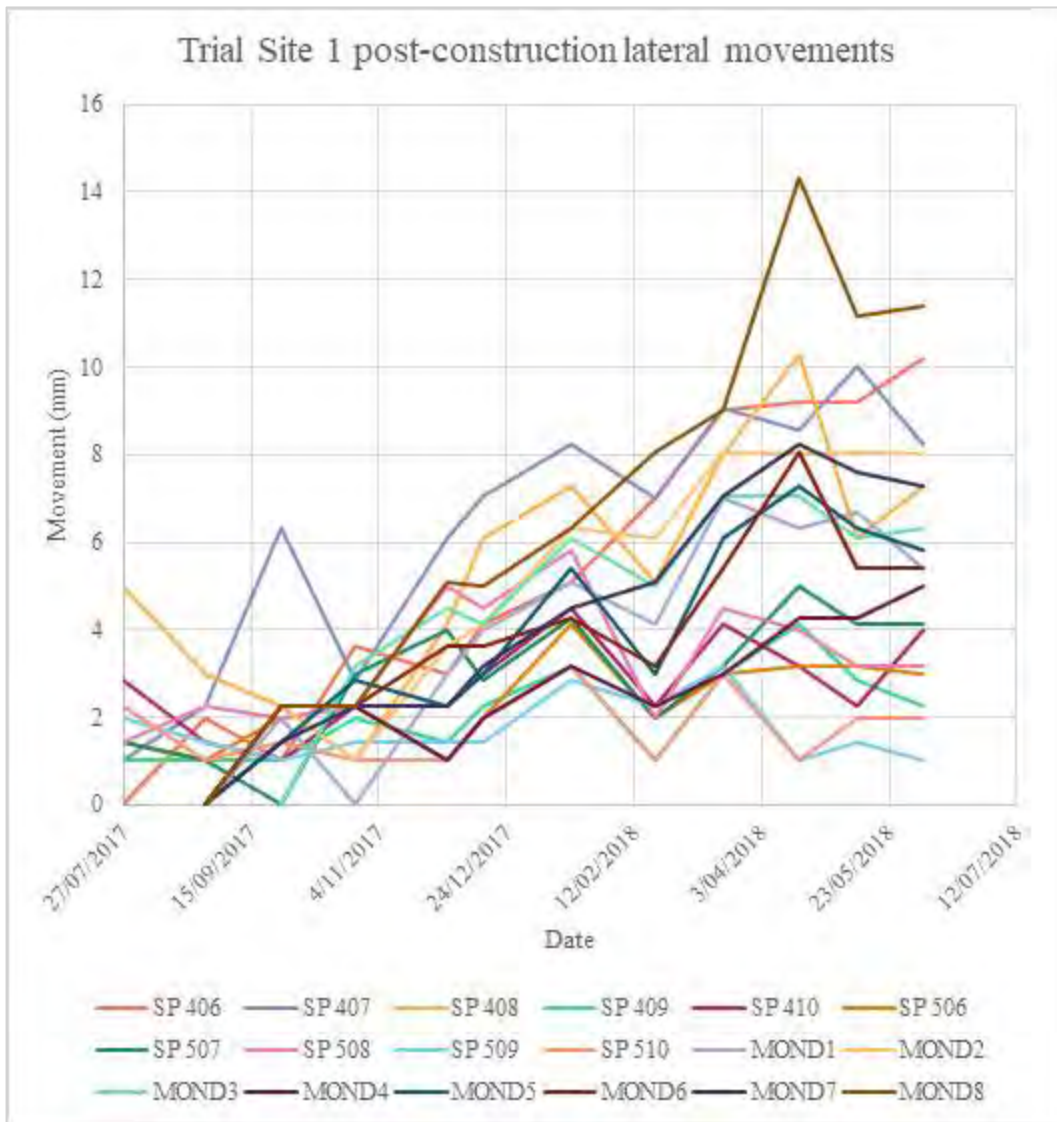
Figure 9: Trial Site 1 post-construction lateral movements (produced from measurements provided in Golder May 2018 monitoring report, ref. [11])

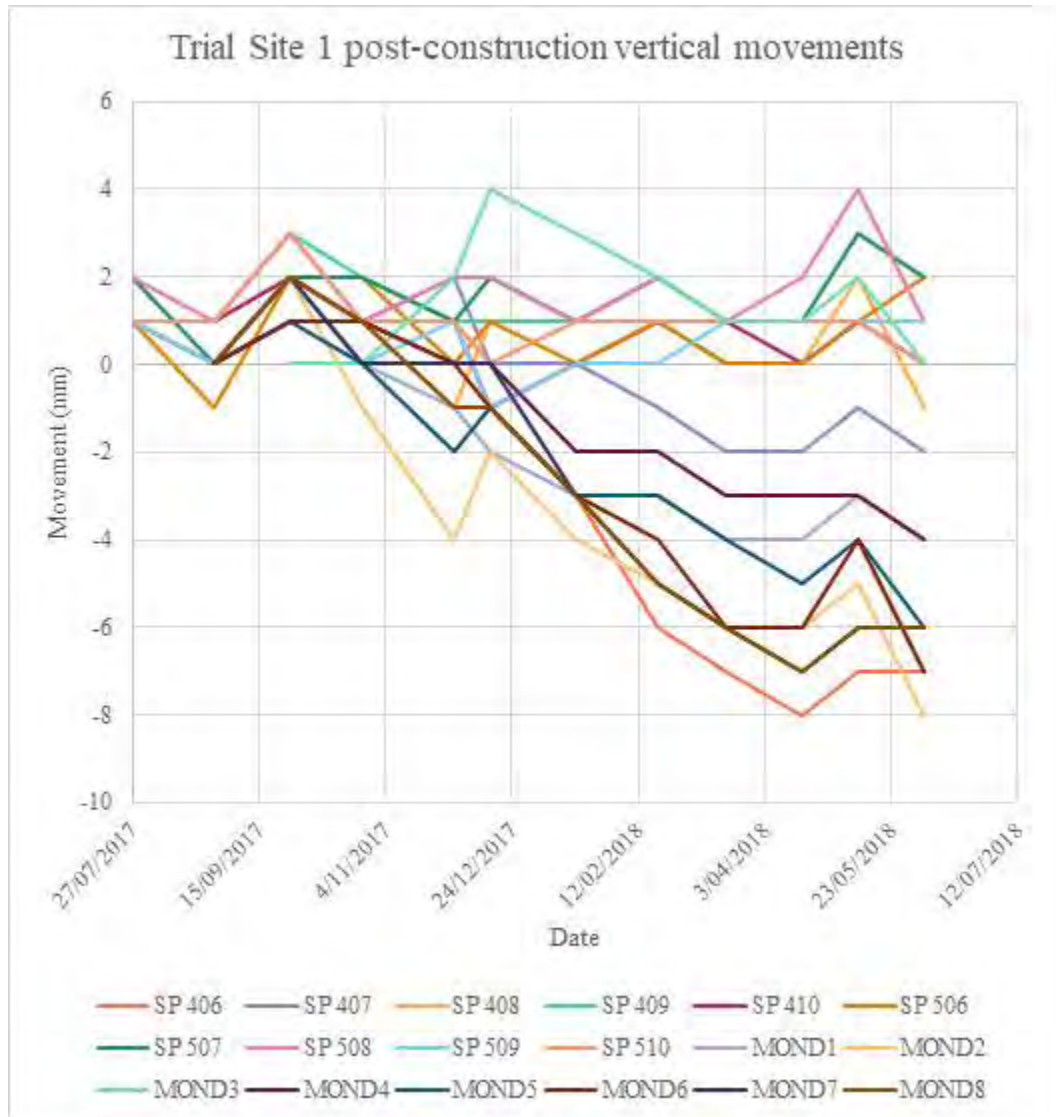
Figure 10: Trial Site 1 post-construction vertical movements (produced from measurements provided in Golder May 2018 monitoring report, ref. [11])

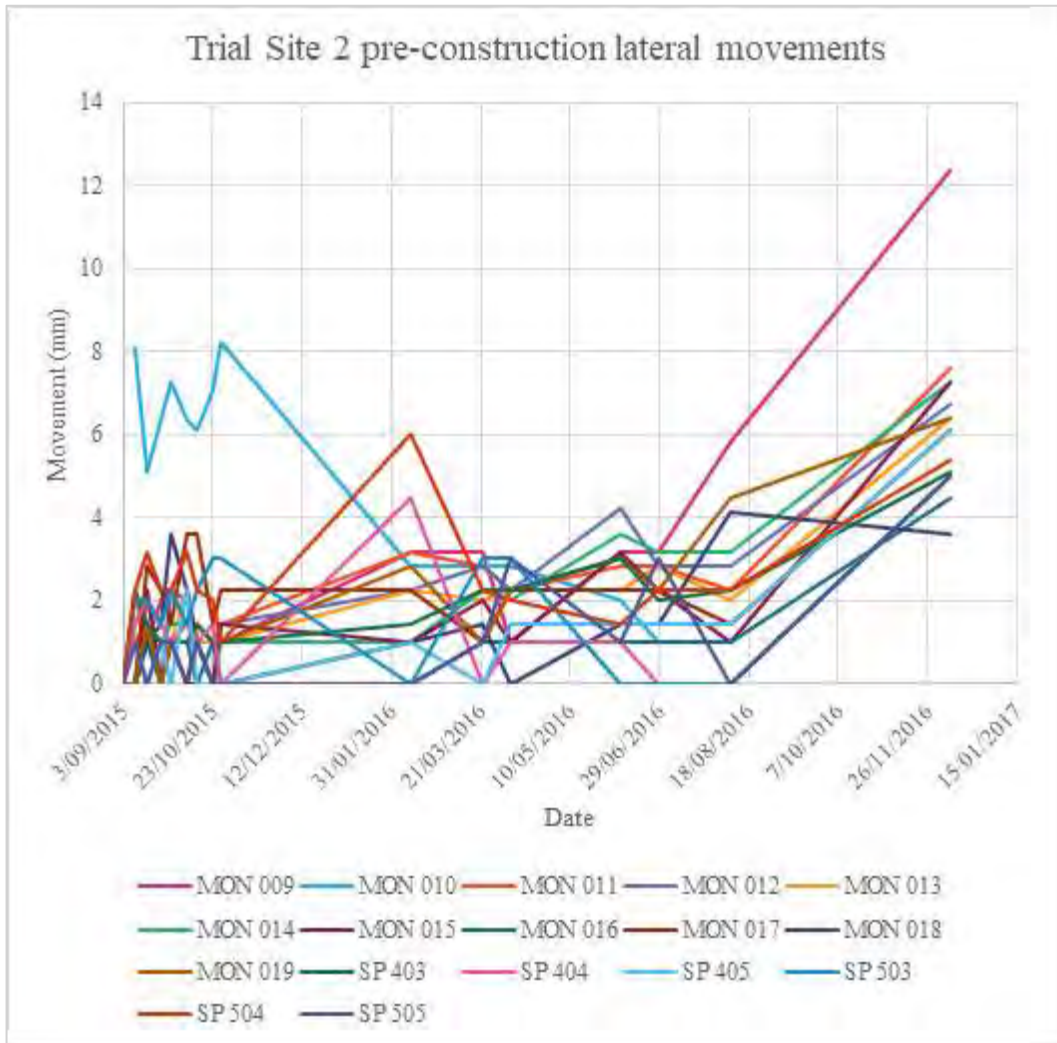
Figure 11: Trial Site 2 pre-construction lateral movements (produced from measurements provided in Golder May 2018 monitoring report, ref. [10], mismeasurements not plotted for clarity)

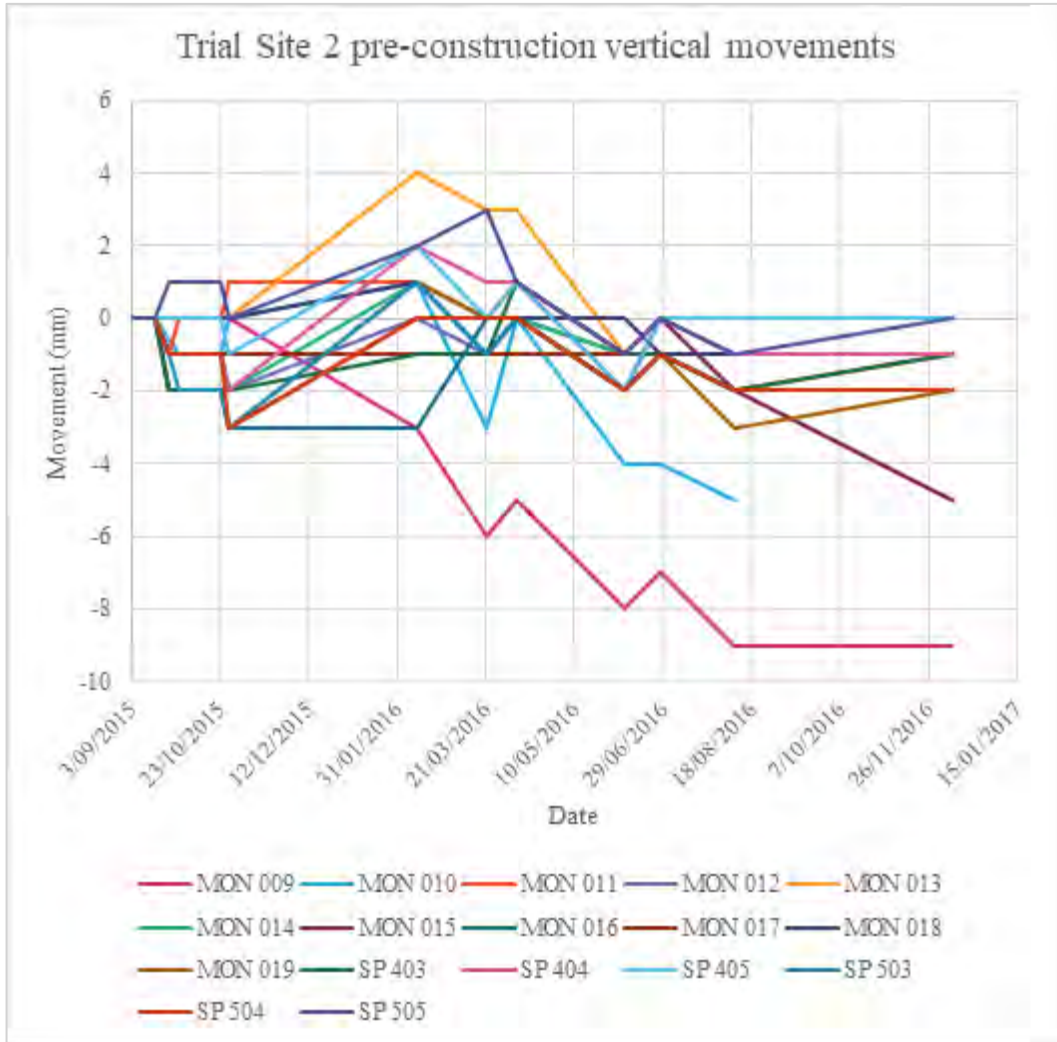
Figure 12: Trial Site 2 pre-construction vertical movements (produced from measurements provided in Golder May 2018 monitoring report, ref. [10], mismeasurements not plotted for clarity)

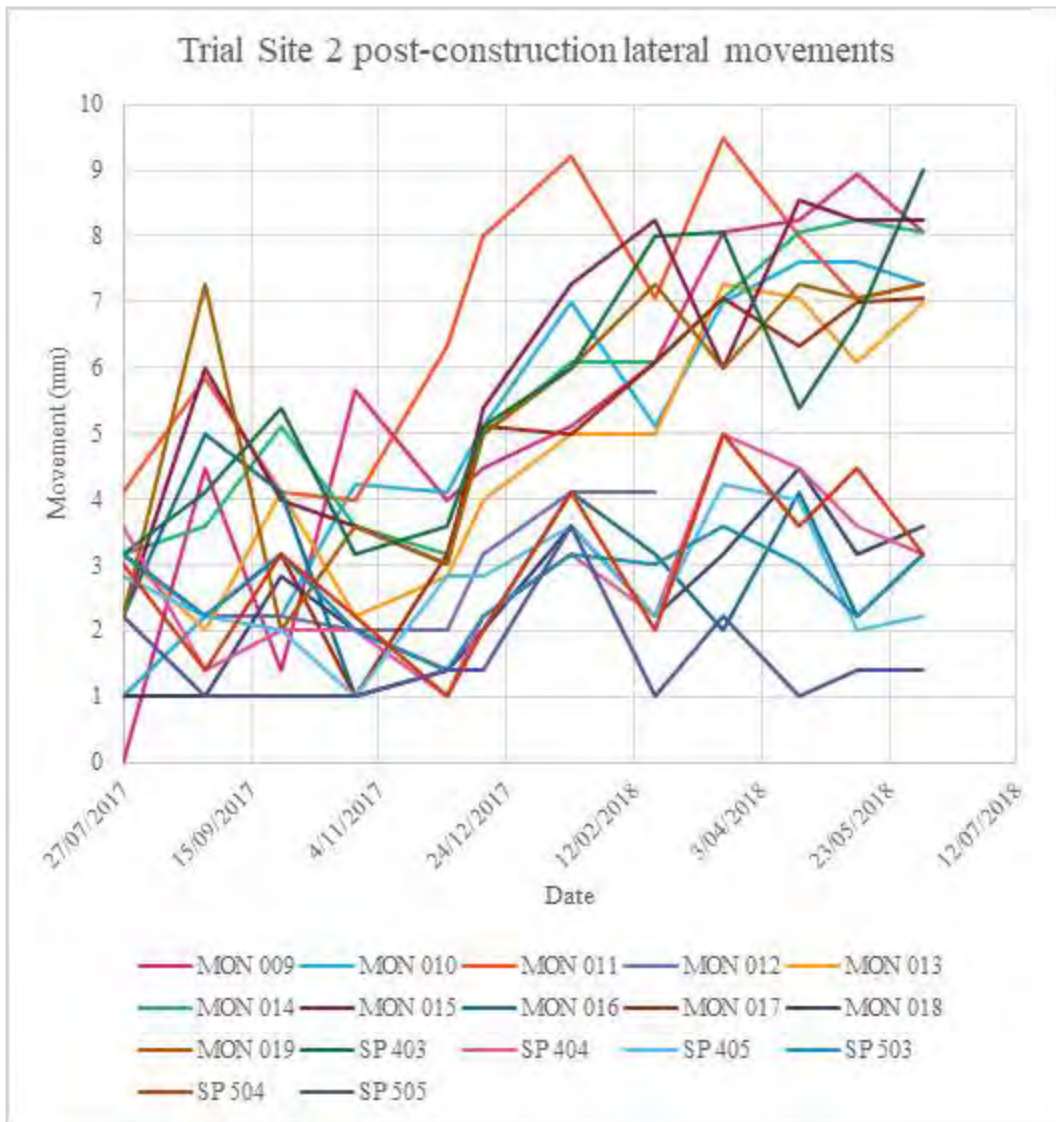
Figure 13: Trial Site 2 post-construction lateral movements (produced from measurements provided in Golder May 2018 monitoring report, ref. [11])

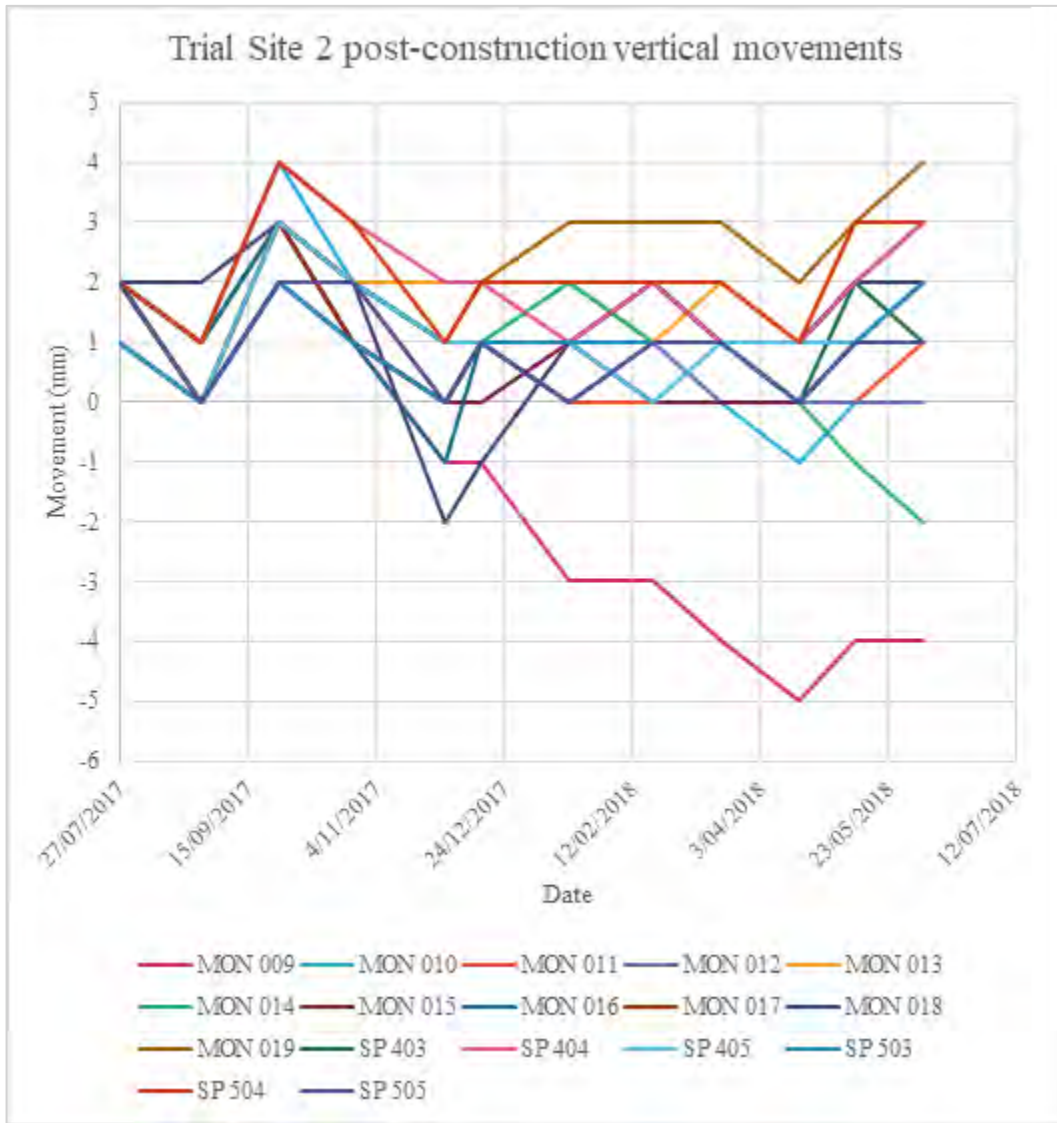
Figure 14: Trial Site 2 post-construction vertical movements (produced from measurements provided in Golder May 2018 monitoring report, ref. [11])

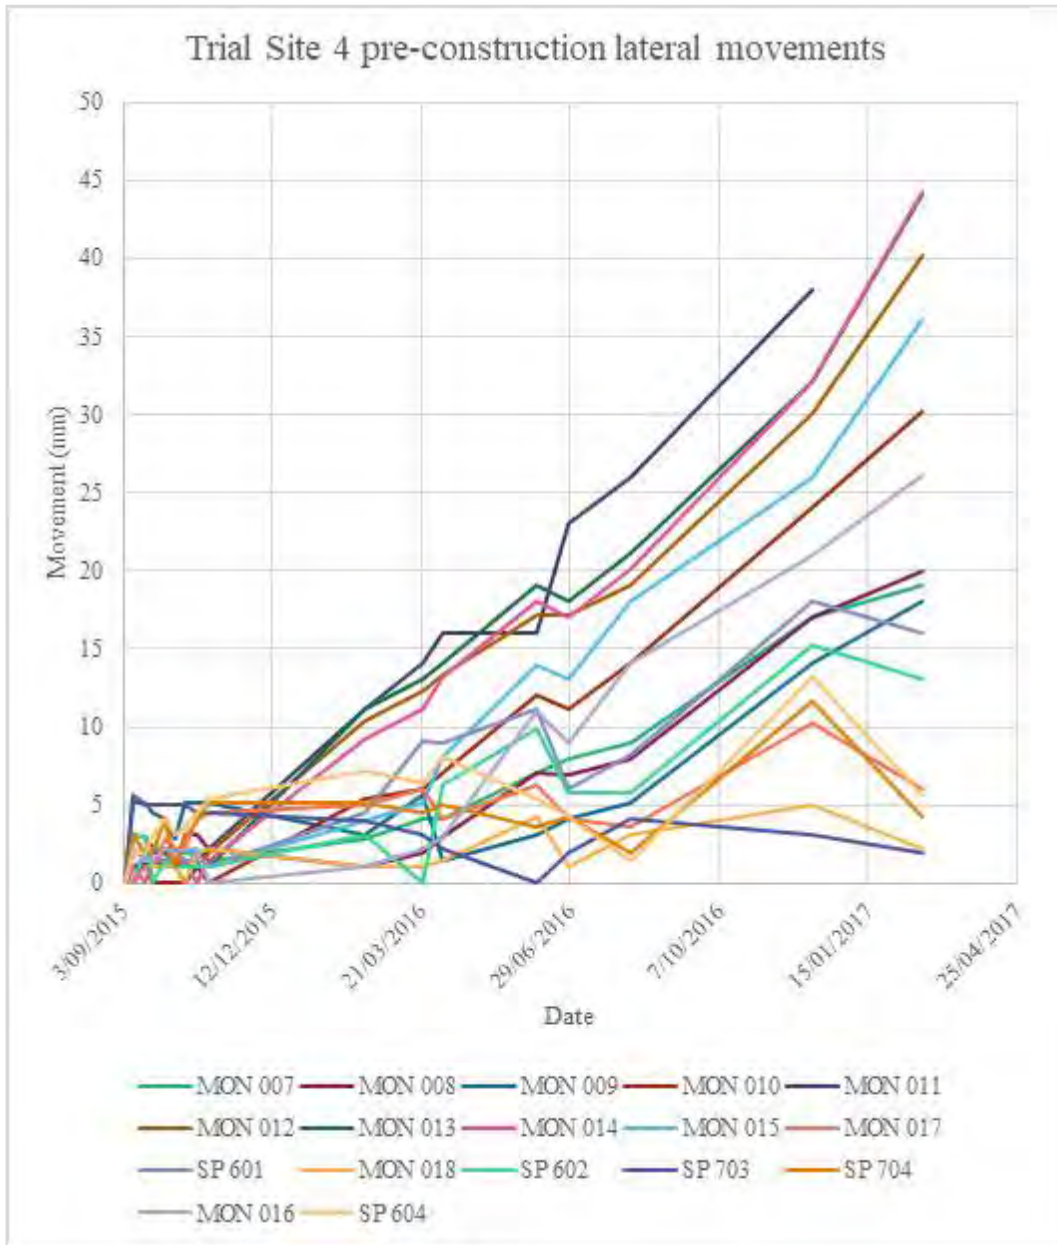
Figure 15: Trial Site 4 pre-construction lateral movements (produced from measurements provided in Golder May 2018 monitoring report, ref. [10], mismeasurements not plotted for clarity)

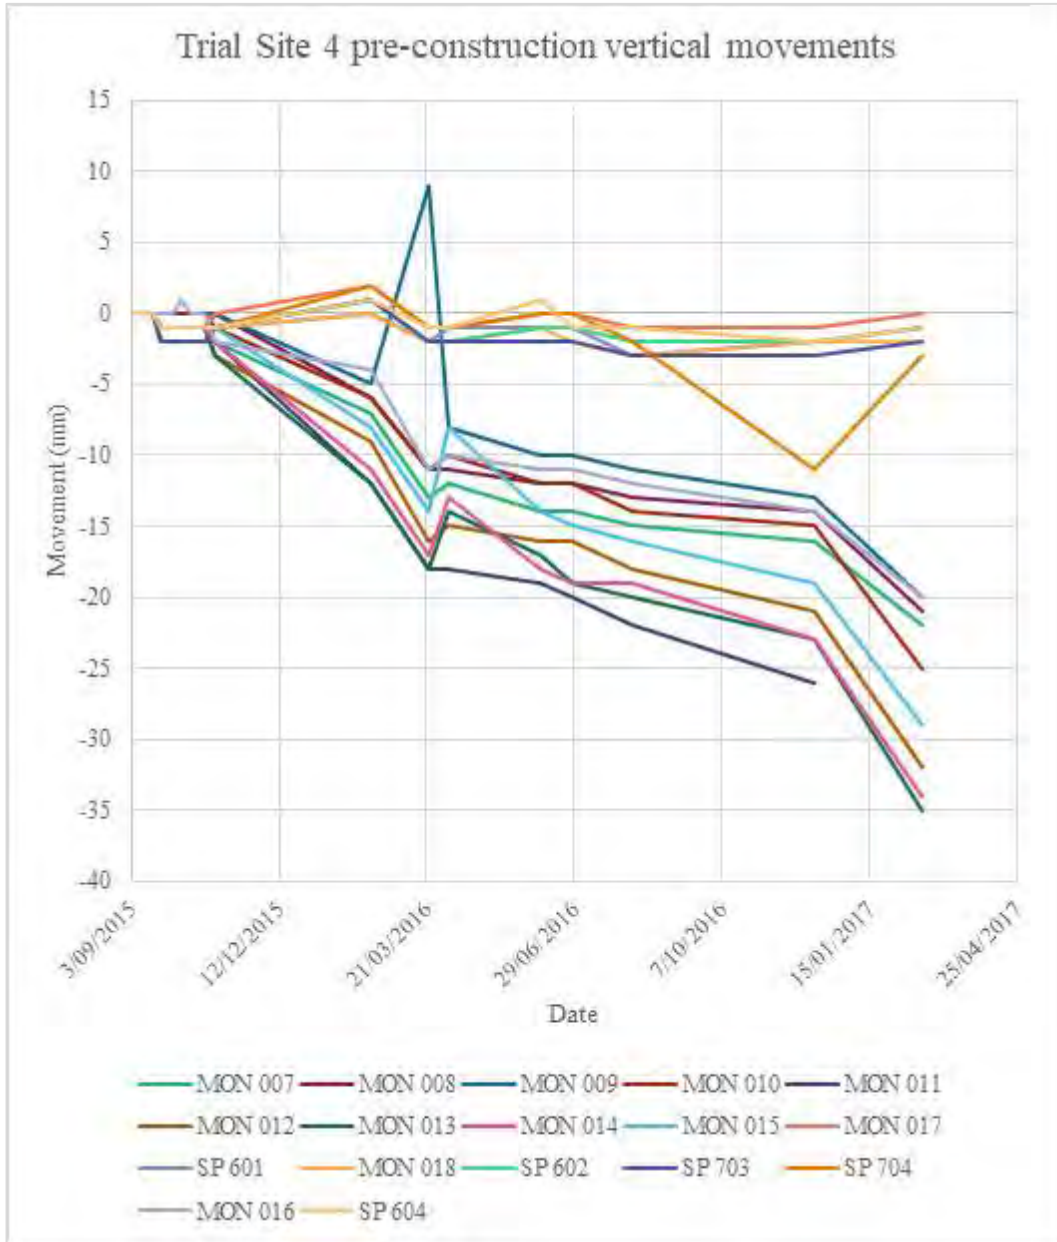
Figure 16: Trial Site 4 pre-construction vertical movements (produced from measurements provided in Golder May 2018 monitoring report, ref. [10], mismeasurements not plotted for clarity)

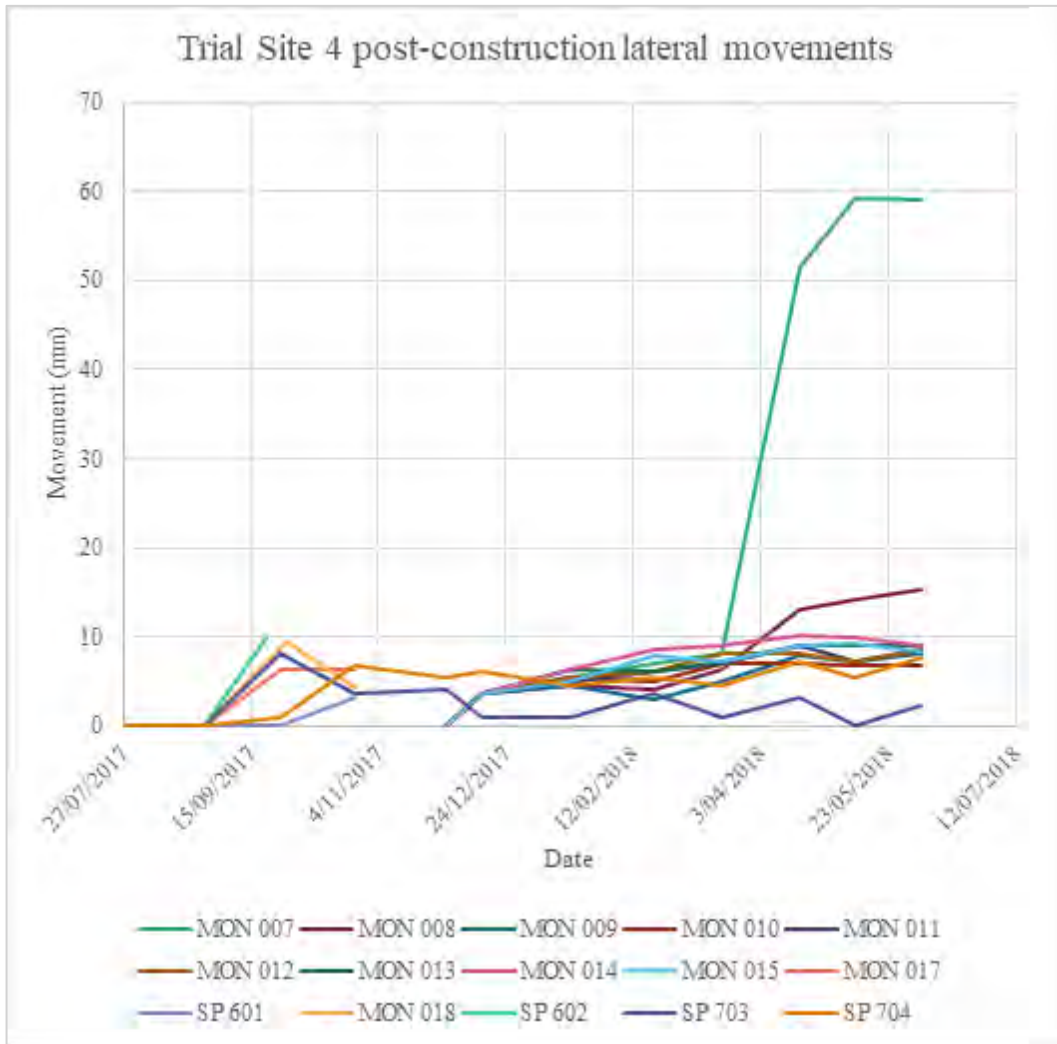
Figure 17: Trial Site 4 post-construction lateral movements (produced from measurements provided in Golder May 2018 monitoring report, ref. [11], mismeasurements not plotted for clarity)

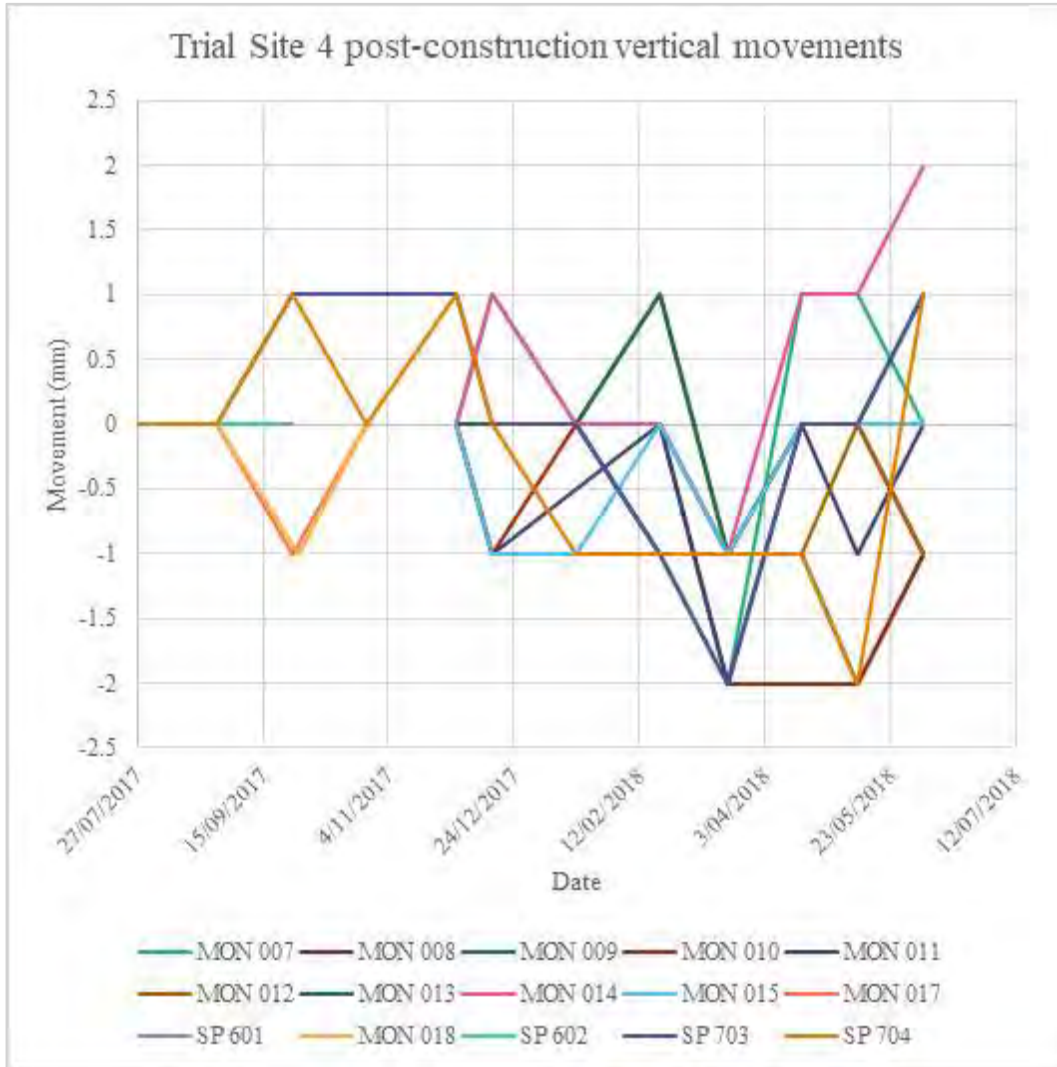
Figure 18: Trial Site 4 post-construction vertical movements (produced from measurements provided in Golder May 2018 monitoring report, ref. [11], mismeasurements not plotted for clarity)

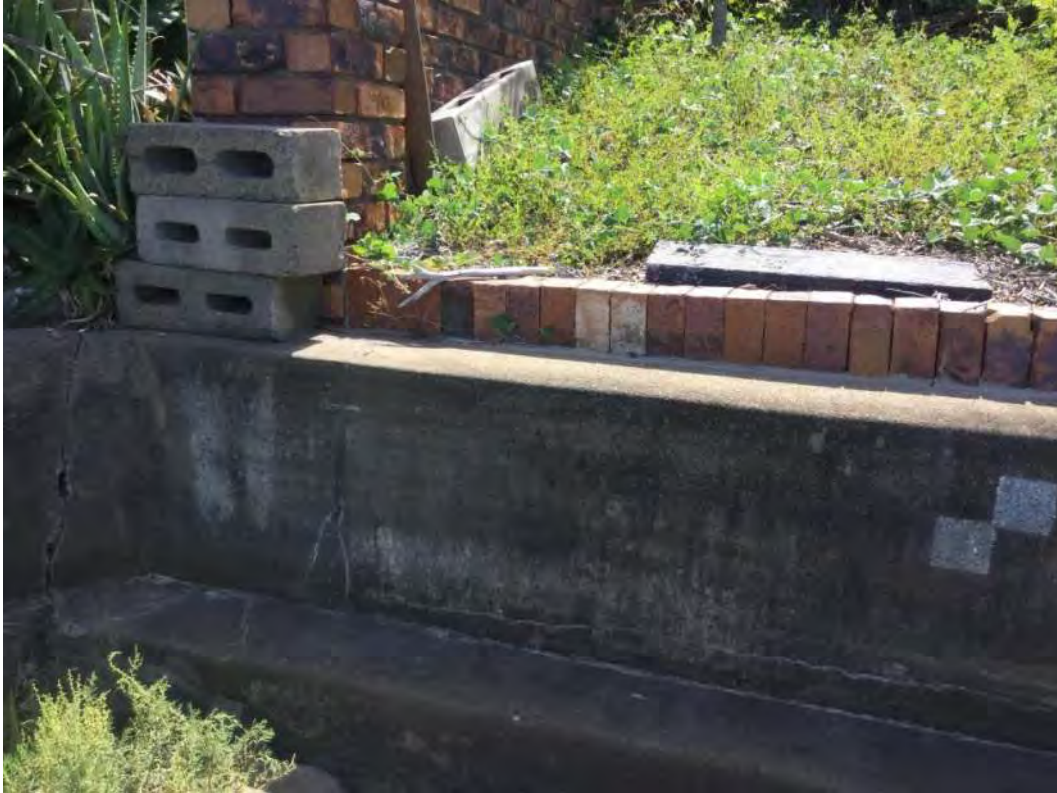
Figure 19: 7-9 Sternlight Court - Pre-construction view of southern boundary looking west, dated 25 January 2017

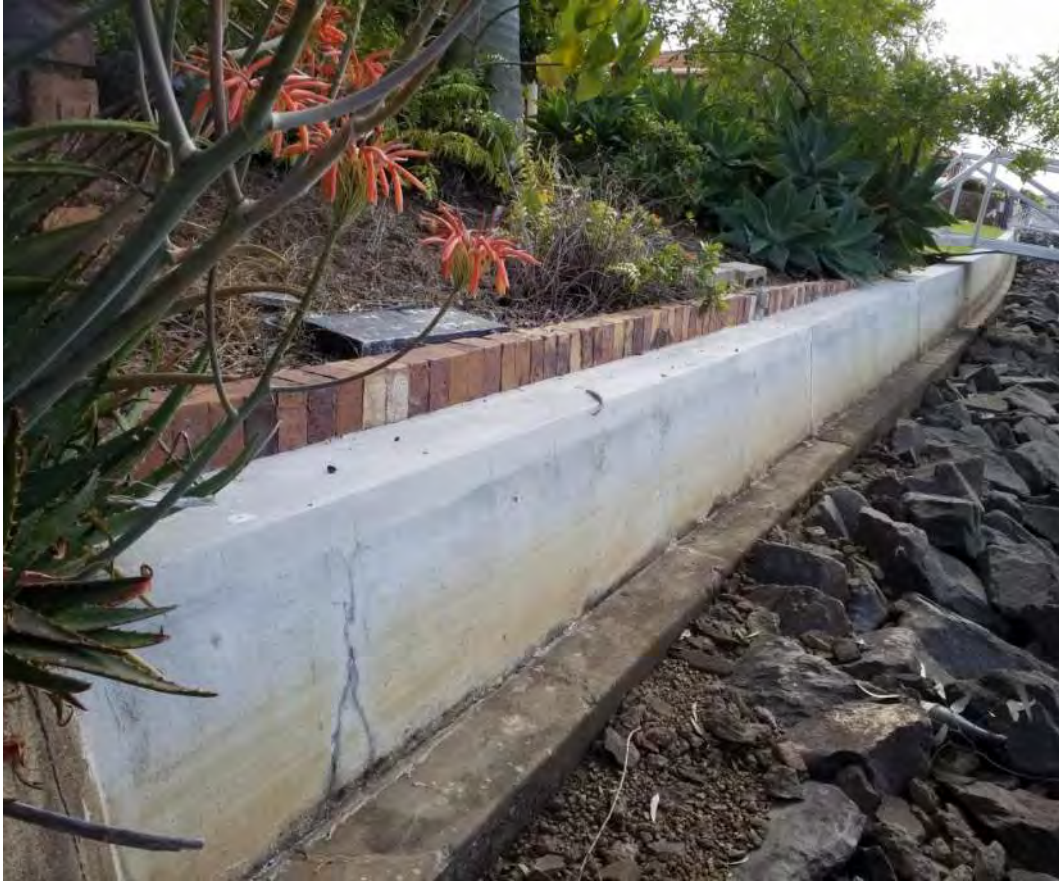
Figure 20: 7-9 Sternlight Court - Post-construction view looking north from the southern boundary, dated 20 June 2018 (from [12])
